## CASE STUDY ON THE BREAKING OF A RAIL AXLE SLUČAJ LOMA VAGONSKE OSOVINE

Originalni naučni rad / Original scientific paper  
UDK /UDC: 629.467.083  
Rad primljen / Paper received: 22.09.2014

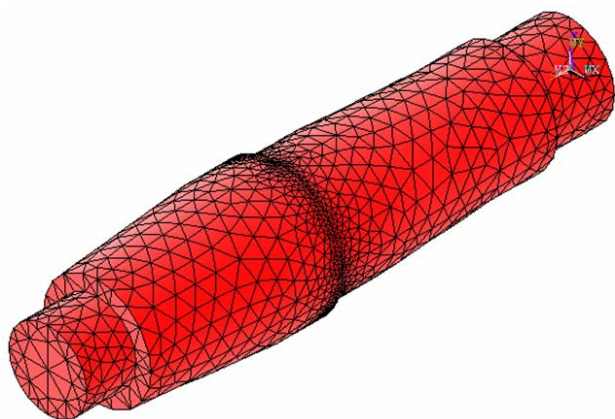
Figure 13. The meshing of the rail axle.  
Slika 13. Mreža vagonke osovine

The rail axle is checked in terms of stress state by means of FEM /8-11/, Fig. 13. The most important stress factors that can act simultaneously on a rail axle are analysed: the weight of the machine and accessory, arm position, wheel torque, braking torque and shock, in combination with several stress conditions (geometry profile and condition of railway), which may lead to limit stress cases (Fig. 14-15).
