LOW-TEMPERATURE CORROSION DAMAGE AND REPAIR OF BOILER BOTTOM PANEL TUBES

Originalni naučni rad / Original scientific paper

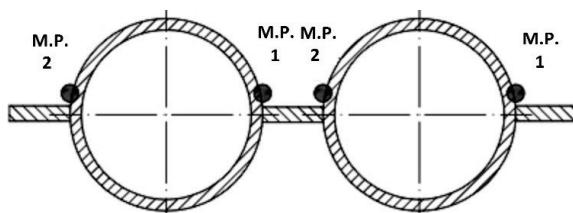
After determining the necessity to increase the extent of repairs, wall thickness testing was also extended. Additional measurements were performed, however, this time including the first six tubes (1-6) and the last six tubes (30-35) as well. It was determined that they too were damaged due to exploitation conditions. Measuring is performed in the cross-section at a distance of 1300 mm from the front tube panel, on two measuring locations in all tubes (Fig. 4). The tubes were once again dismantled, but this time the chamotte located near the firebox screen edges was also removed in order to release tubes 1 and 35. The tubes were again cut and subjected to further tests, and later on, to repair welding in order to eliminate the damage. Results of tube wall thickness measurements are shown in Table 1.

Figure 4. Measuring points (M.P.) in the tubes.
