ANALYSIS OF REMEDIATION OF MANIFOLD LINE DAMAGED BY LONGITUDINAL CRACK IN THE PIPING ELBOW OF OIL AND GAS WELL COLLECTOR

Originalni naučni rad / Original scientific paper
UDK /UDC:

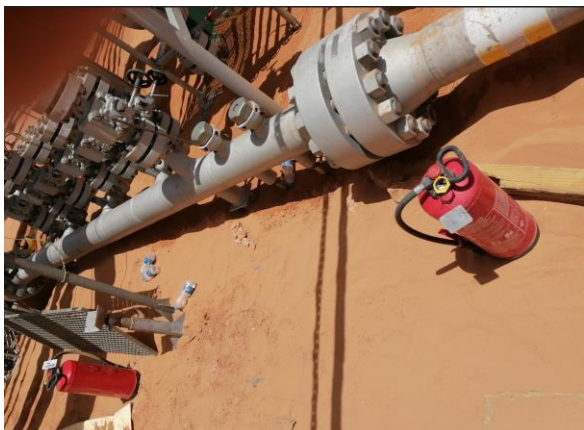
For that occasion we provided a sufficient number of portable powder firefighting apparatus, uniformly distributed in the cutting- and welding area (Fig. 13).

Figure 13. Firefighting apparatus in the welding area.

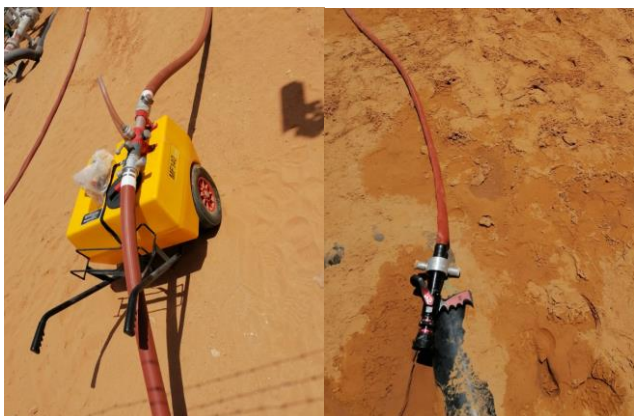
Together with these firefighting apparatus with powder, a water pump and moveable tank were also provided as a water firefighting means (Fig. 14).

Figure 14. Water-based firefighting equipment.
