## DAMAGE ANALYSIS AND RESTORING OF STRUCTURAL INTEGRITY OF PELTON RUNNER AFTER REPAIR WELDING: CASE STUDY

*This paper presents the repair welding technology of a Pelton runner blade, including an analysis of damage caused by cavitation. Extreme exploitation conditions resulted in crack initiation followed by its propagation, with a length 200 mm, detected during regular annual maintenance, compromising Pelton turbine's structural integrity. The base material of the Pelton turbine was steel X3CrNiMo13-4, and as well as the blade geometry itself, required special attention during the process of defining repair welding technology. An austenitic electrode was used for this purpose along with a welding technology defined in a way to counter the initiation of new cracks at the same location. Following the NDT, the Pelton runner was put back into exploitation, along with recommendations for its further monitoring.*

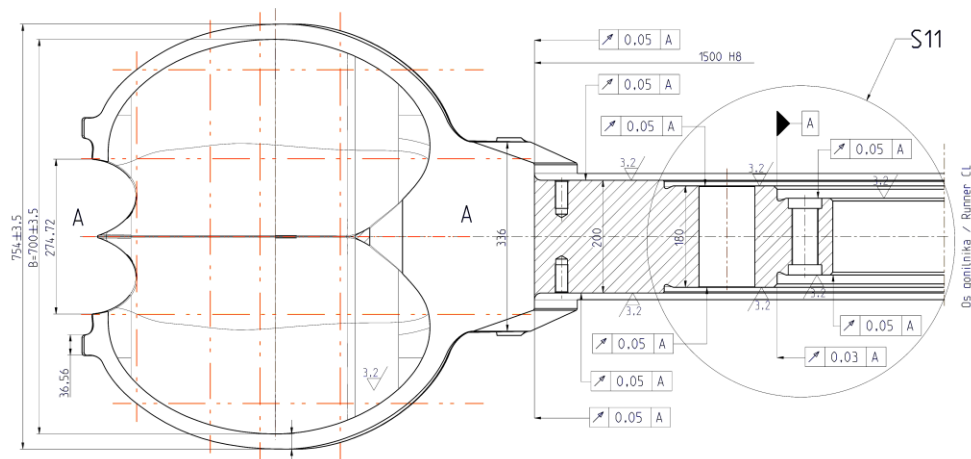
Figure 2. Geometry of Pelton runner blade

To understand this particular problem regarding blade's cracking, this subchapter begins with Pelton runner blade (characteristic's) geometry, given in Fig.2. Notably, blade thickness is just 4 mm exposed to extreme condition with expected cavity and high loading due to water flow causing high stress at the blade edge.
