## REPAIR AND STRUCTURAL INTEGRITY ASSESSMENT OF A LARGE SPHERICAL TANK POPRAVKA I PROCENA INTEGRITETA VELIKOG SFERNOG REZERVOARA

Tests aimed at assessing the integrity of a pressure vessel are performed on a spherical tank for liquid petroleum gas (LPG marked R-113), Fig. 1. The R-113 spherical tank has been in operation since 1974, which is a sufficient reason to carry out an integrity assessment, bearing in mind that the NDT tests performed during periodical inspection revealed crack-type flaws that were detected by magnetic particle testing and ultrasound. The crack front length ranged from 5 to 150 mm. Unacceptable flaws of the crack type need to be repaired at locations where crack type flaws are detected.

Technical data: volume 600 m<sup>3</sup>, LPG medium, working pressure 1.67 MPa, waterproof pressure 2.5 MPa, diameter 10.5 m, and thickness 26 mm.

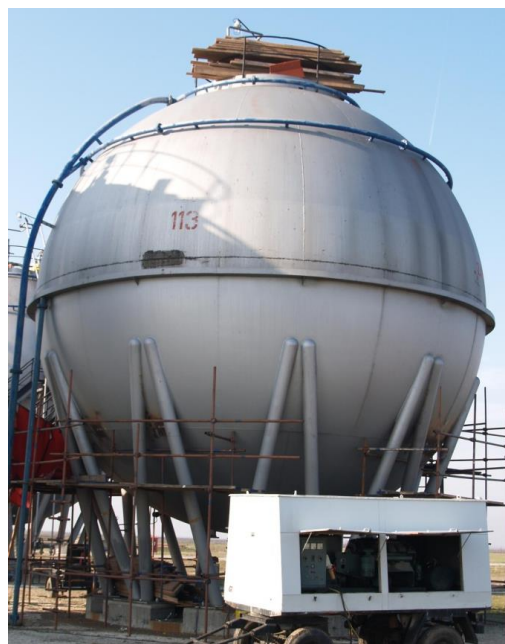
Figure 1. LPG spherical tank, designated as R-113.

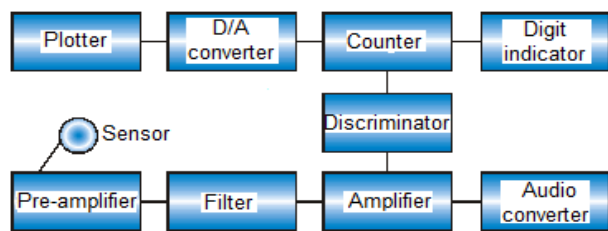
In addition to strain measurements that indicated elastic behaviour, acoustic emission is performed at the same time during waterproof testing, /7-9/. Processing acoustic emission signals is based on ring down counting. Scheme of this testing is shown in Fig. 7.

Figure 7. AE testing scheme.

As one can see from Fig. 8, there is no signal in AE indicating that the repair is performed successfully and proving that the structural integrity of the tank is not compromised.
