## EVALUATION AND SEISMIC RISK OF CONFINED MASONRY BUILDINGS IN THE CITY OF ETEN - CHICLAYO - PERU, 2023

*The results of soil tests, visual inspections and mathematical models of 14 masonry houses belonging to a state programme called 'Techo Propio' (Own Roof), located in the city of Eten, Chiclayo province, Peru, are presented. In order to evaluate the damage to the houses, the probable causes of their predominant pathologies are determined.*

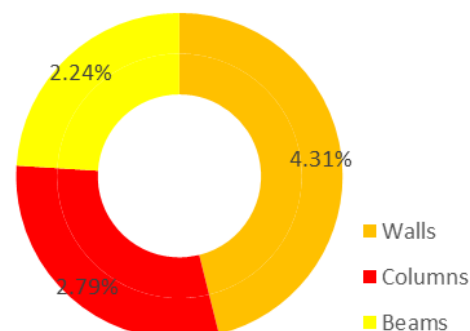
With respect to the structural element most affected by the area presenting the pathology, the following percentages are obtained: 4.31 % for walls, 2.79 % for columns, and 2.24 % for beams (Fig. 6).

Figure 6. Summary of the structural element most affected by the area representing the pathology.
