RECONSTRUCTION OF A DAMAGED ROTOR SPOKE RIB - PART 1: STRESS ANALYSIS REKONSTRUKCIJA OŠTEĆENE NOSEĆE GREDE ROTORA - DEO 1: NAPONSKA ANALIZA

Originalni naučni rad / Original scientific paper

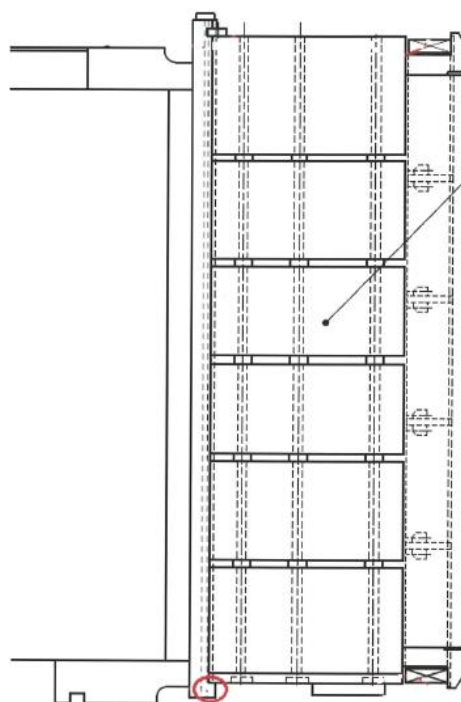
The rotor spoke is a vital supporting component of the large vertical generator construction in the Reversible Hydro Power Plant (RHPP) Bajina Bašta in Serbia, as schematically shown in a simplified way in Fig. 1. Main supporting elements of the rotor spoke are 8 ribs (beams), dimensions 250×119.5×3461 mm, Fig. 2a, welded vertically along the length and horizontally along the circumference, Fig. 2b-c. Along entire ribs length grooves were made, 55×56 mm, to accommodate wedges, Fig. 2c-d.

Figure 1. Rotor assembly.

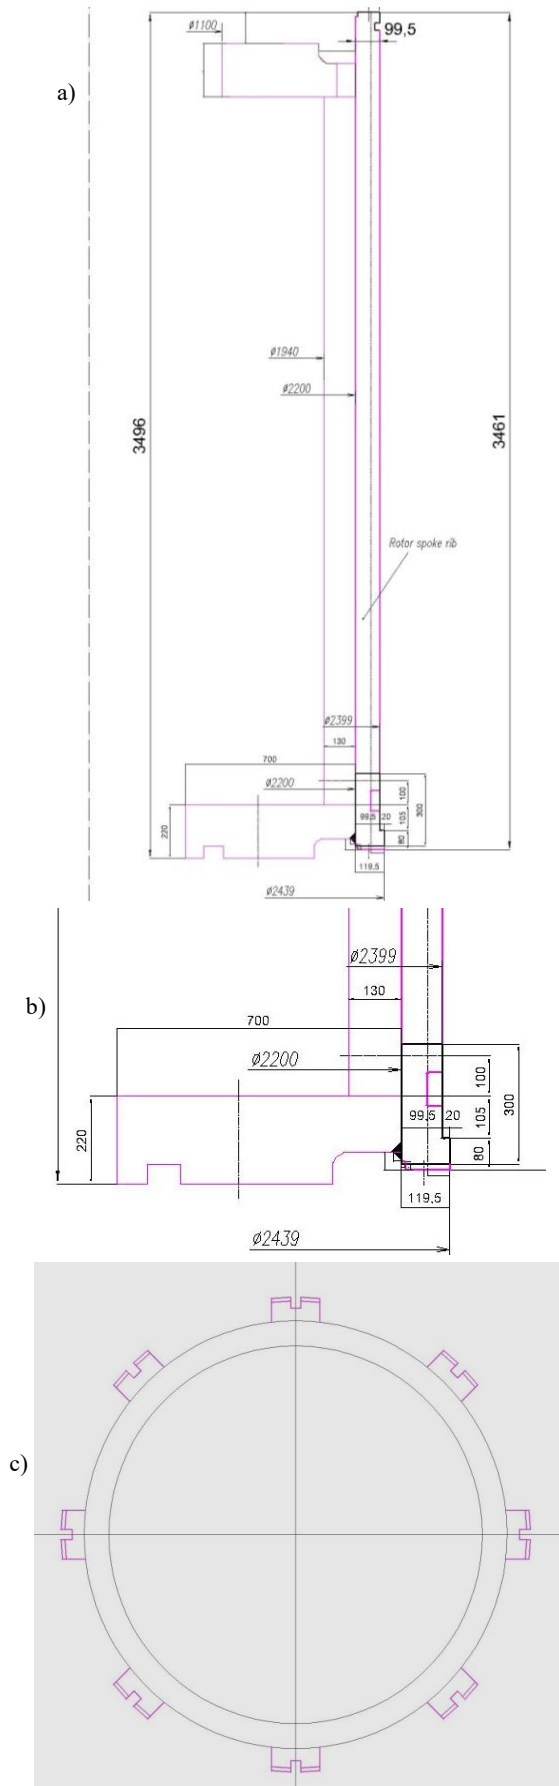
Figure 2. Details of rotor spoke ribs.
