UTICAJ USLOVA OPTEREĆENJA NA LOM ZAVARENOG TANKOZIDNOG REZERVOARA LOADING CONDITION EFFECT ON THE FRACTURE OF WELDED THIN-WALLED **STORAGE TANK**

| Stručni rad / Professional paper UDK /UDC: 621.642-988-112.81:539.42 Rad primljen / Paper received: 17.01.2007. | Adresa autora / Author's address: ¹⁾ Zavod za zavarivanje, Beograd, Srbija, <u>zzz@bitsyu.net</u> ²⁾ Fakultet tehničkih nauka, Novi Sad,Srbija ³⁾ Tehnološko-metalurški fakultet, Beograd, Srbija |

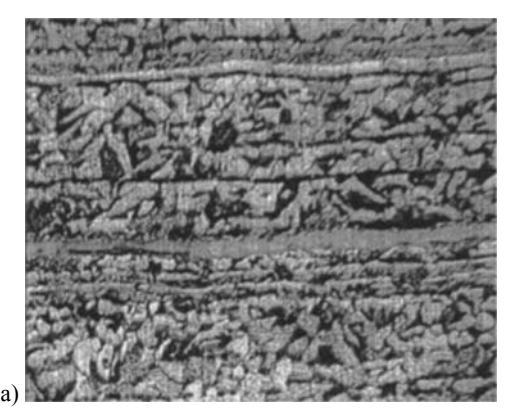
The storage tank mantle (vessel I) was produced of structural steel S355J2G3 EN 10025, 8 mm thick. Chemical composition of mantle parent metal is given in Table 1, and mechanical properties in Table 2. The microstructure banding is expressed and non-uniform pearlite distribution, with secondary structure, sulphide inclusions and segregations. Ferrite grain size is 9–10 (×200), JUS C.A3.004 (Fig. 1a).

Slika 1. Mikrostrukture ispitivanih čelika. (a) čelik S355J2G3 (posuda I), (b) čelik Nioval 47 (posuda II) Figure 1. Microstructures of investigated steels. (a) steel S355J2G3 (vessel I), (b) Nioval 47 steel (vessel II).
