POČETNO STANJE NAPONA CEVI KOTLA ZA OCENU INTEGRITETA KONSTRUKCIJE INITIAL STRESS STATE OF BOILER TUBES FOR STRUCTURAL INTEGRITY ASSESSMENT

Stručni članak / Professional paper
UDK /UDC: 620.179: 621.18
Rad primljen / Paper received: 27.11.2006.

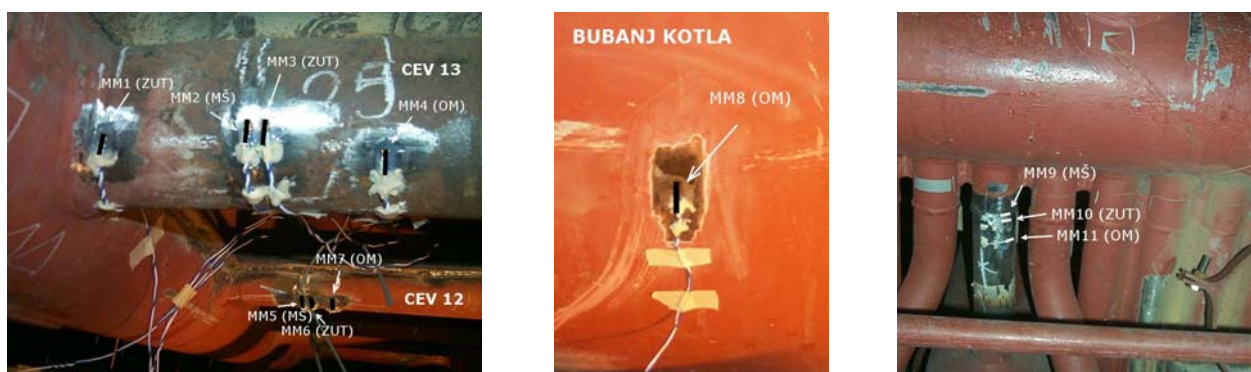
Slika 4. Zone i merna mesta za praćenje deformacija pri probnom ispitivanju pritiskom
Figure 4. Zones and measuring locations for monitoring strains during pressure proof test.

- zone I on tube 13, locations 1 to 4, and zone II on tube 12, locations 5 to 7;
- zone III on boiler drum, measuring location 8;
- zone IV on tube 52, measuring locations 9 to 11.

- Zona I, cev 13, merna mesta 1 do 4, zona II, cev 12, merna mesta 5 do 7
- Zona III, doboš kotla, merno mesto 8
- Zona IV, cev 52, merna mesta 9 do 11

Stress calculations from microstrains measured by strain gauges during the pressure proof test showed elastic behaviour of material (Fig. 5) in all zones of tubes and boiler drum, with maximal value of 99.3 MPa in boiler drum and 66 MPa in tube 52.
