**OPRAVKA DOBOŠA KOTLA SA PRSLINAMA OD NAPONSKE KOROZIJE
POSTUPKOM HLADNOG ZAVARIVANJA***

COLD WELD REPAIR OF A STRESS CORROSION CRACKED BOILER DRUM[#]

Stručni rad / Professional paper

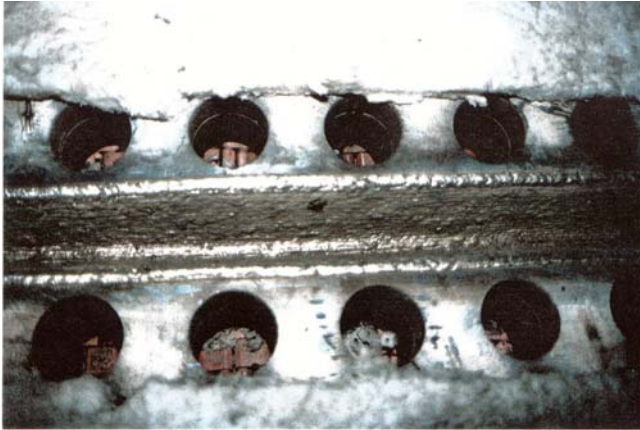
The buttering layer is presented in Fig. 12. After this layer deposition, a grinding to the half of its thickness was required (Fig. 13), first to eliminate any possible non-metallic residuals and second to get a better HAZ heat treatment effect by next pass. The preheating was achieved by insulating the plate and using electric resistance heaters (Fig. 14). Applied asymmetric U shape weld had 2/3 to 1/3 preparation.

Slika 12. Nanošenje puterovanog sloja
Figure 12 – Buttering layer deposition

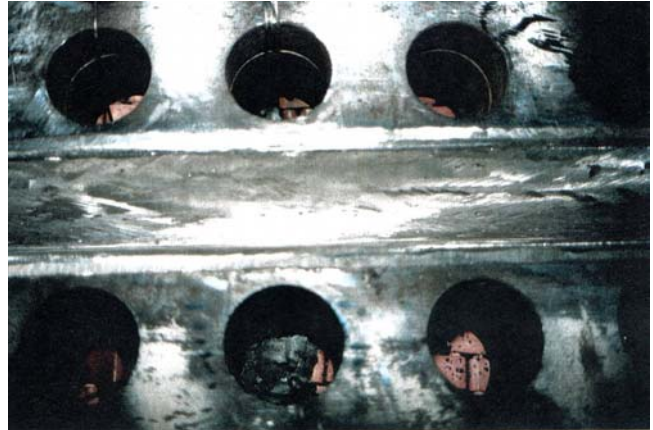
Slika 13. Brušenje puterovanog sloja
Figure 13 – Grinding of the buttered layer

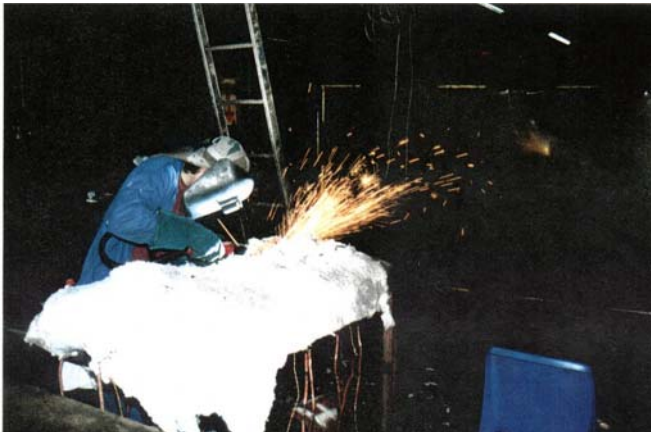
Slika 14. Materijal za izolaciju i grejač sa električnim otporom
Figure 14 – Insulating material and electrical resistance heater

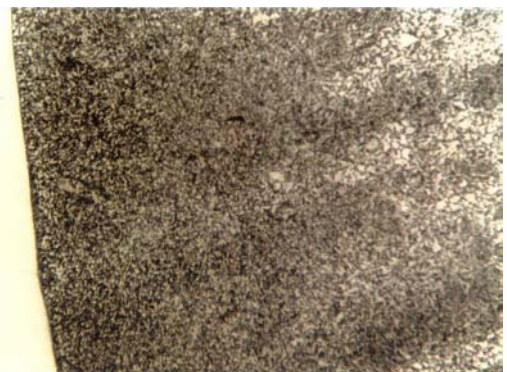
Popravljena ispitna ploča je prikazana na sl. 16. Makrofotografije poprečnog preseka (sl. 17) otkrivaju usku ZUT i vrlo čist metal šava (bez grešaka i nemetalnih uključaka). Mikrostruktura ZUT je sitnozrnasta (sl.18), čime je potvrđen uticaj otpuštanja narednim prolazom. Ovi rezultati su isključili prisustvo martenzita.

Slika 18. Mikrostruktura ZUT (200x)
Figure 18 - HAZ microstructure (200x)

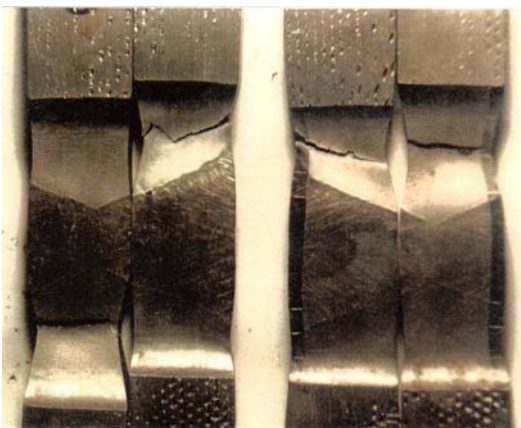
Samples had been extracted from this plate to assess mechanical, chemical and physical properties of the weld according to ASME Sect. IX. Transverse tensile test specimens fractured in parent metal (Fig. 19). Transverse side bend test revealed no HAZ cracking (Fig. 20). Hardness in HAZ is up to 264 HV 10.

Slika 19. Epruvete za poprečno zatezanje
Figure 19 - Transverse tensile test specimens
