Taško Maneski¹
Dragan Ignjatović²

SANACIJE I REKONSTRUKCIJE ROTORNIH BAGERA REPAIR AND RECONSTRUCTION OF BUCKET WHEEL EXCAVATORS

Originalni naučni rad / Original scientific paper
UDK /UDC: 620.17:621.879.48
Rad primljen / Paper received: 10.6.2004.

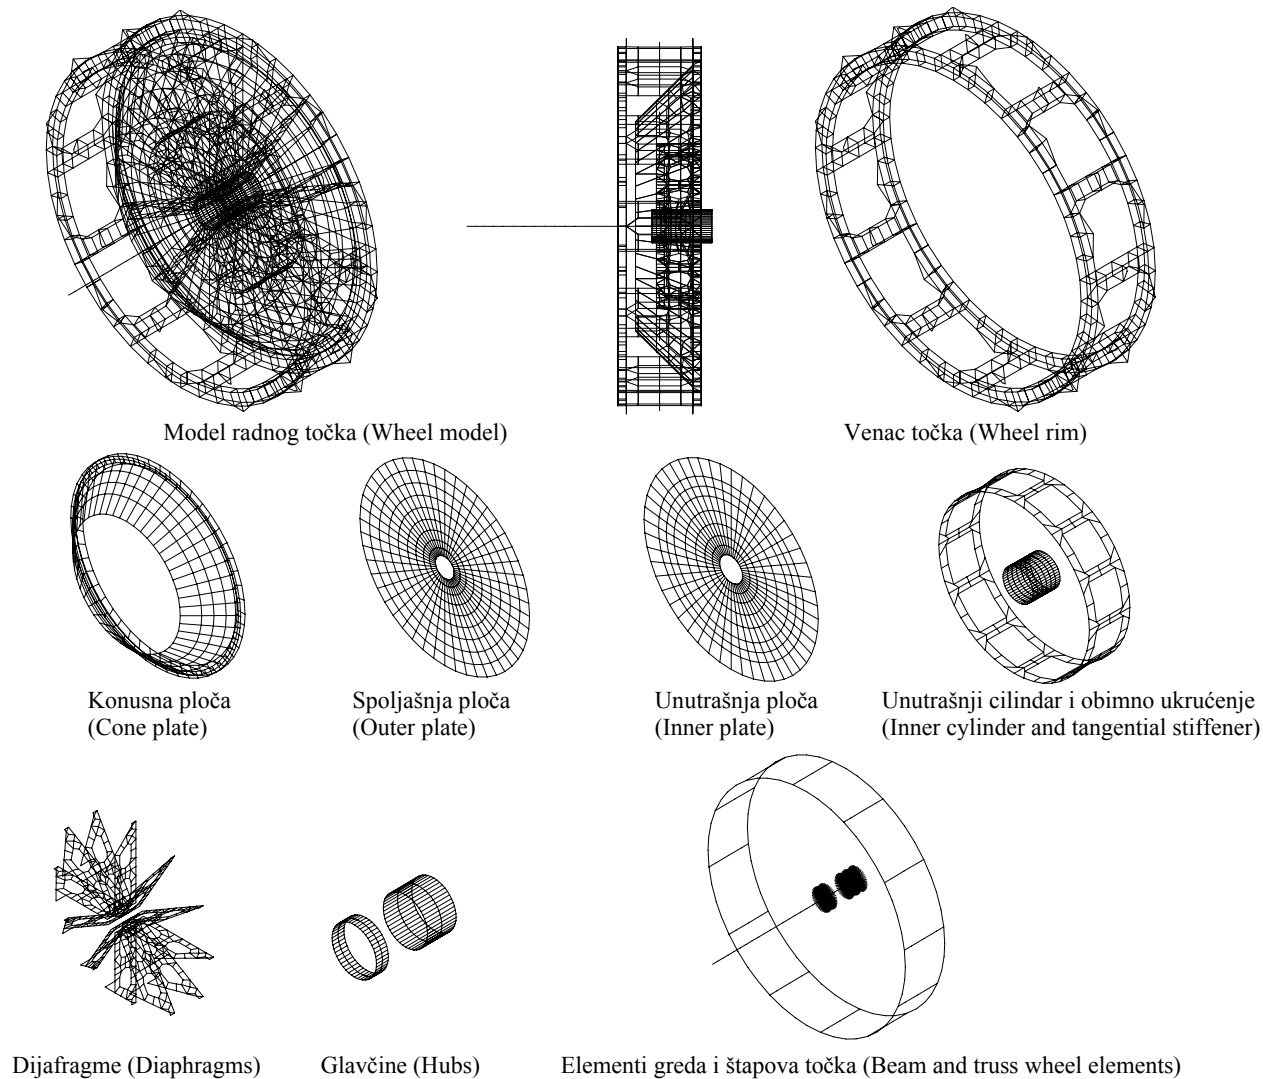
Slika 1. Modeli radnog točka i podstruktura
Figure 1. Wheel models and substructures.

The following operating wheel loads are approved: circumferential force 232.7 kN; lateral force 65.9 kN, per bucket. The discretized operating wheel model, shown in Fig. 1, consists of 409 linear elements and 2952 plate elements. The operating wheel failed in service, causing cracking of connected plates and shafts. The stress fields and distributions are shown in Fig. 2.

The distribution of normal and shear stresses indicates large presence of shear stresses. Membrane stresses are dominant. The analysis undoubtedly shows that the failure is caused by insufficient thickness of the outer plate.

Adding a ring of increased thickness (2 cm instead of 0.8 cm) to the outer plate led to significant stress decrease (from 21.6 to 13.6 kN/cm²) and also to a decrease in the shear stress effect. The wheel has continued to operate successfully.

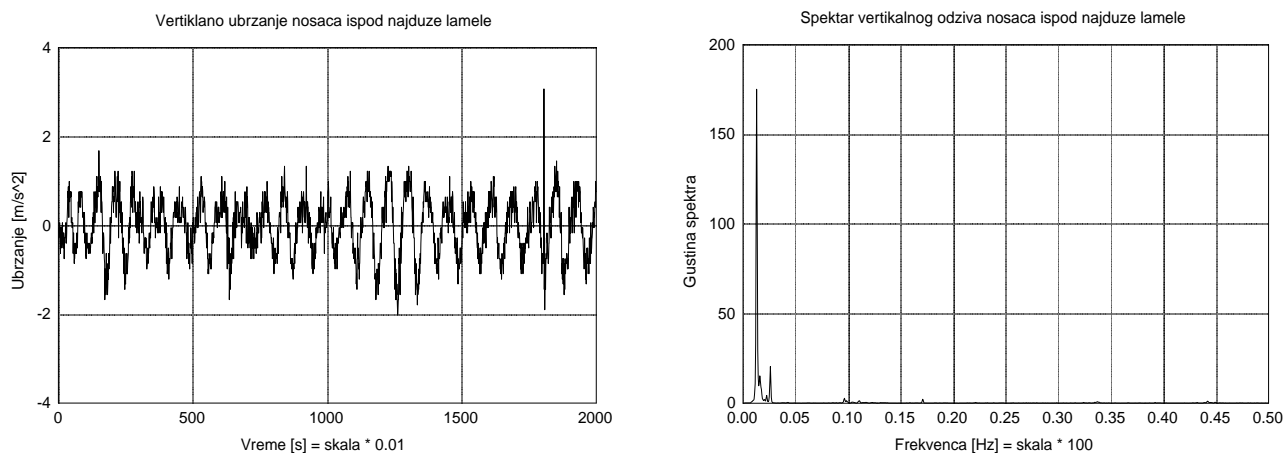
Slika 7. Vertikalno ubrzanje u vremenskom (levo) i gustina spektra u frekventnom domenu (desno)
Figure 7. Vertical acceleration in time (left) and spectrum density in frequency domain (right).

Cantilever reconstruction meant adding two new ties, yoke reinforcement and removal of heavy elements (cameras were placed) (Fig. 5). Numerical results and model are shown in Fig. 6. The cantilever operates successfully. Acceleration measurements were made on the reconstructed beam and ties. Figure 8 shows a measured signal. As can be seen, the acceleration is below the allowed value (2 m/s^2) and with no response of cantilever eigen-frequency.

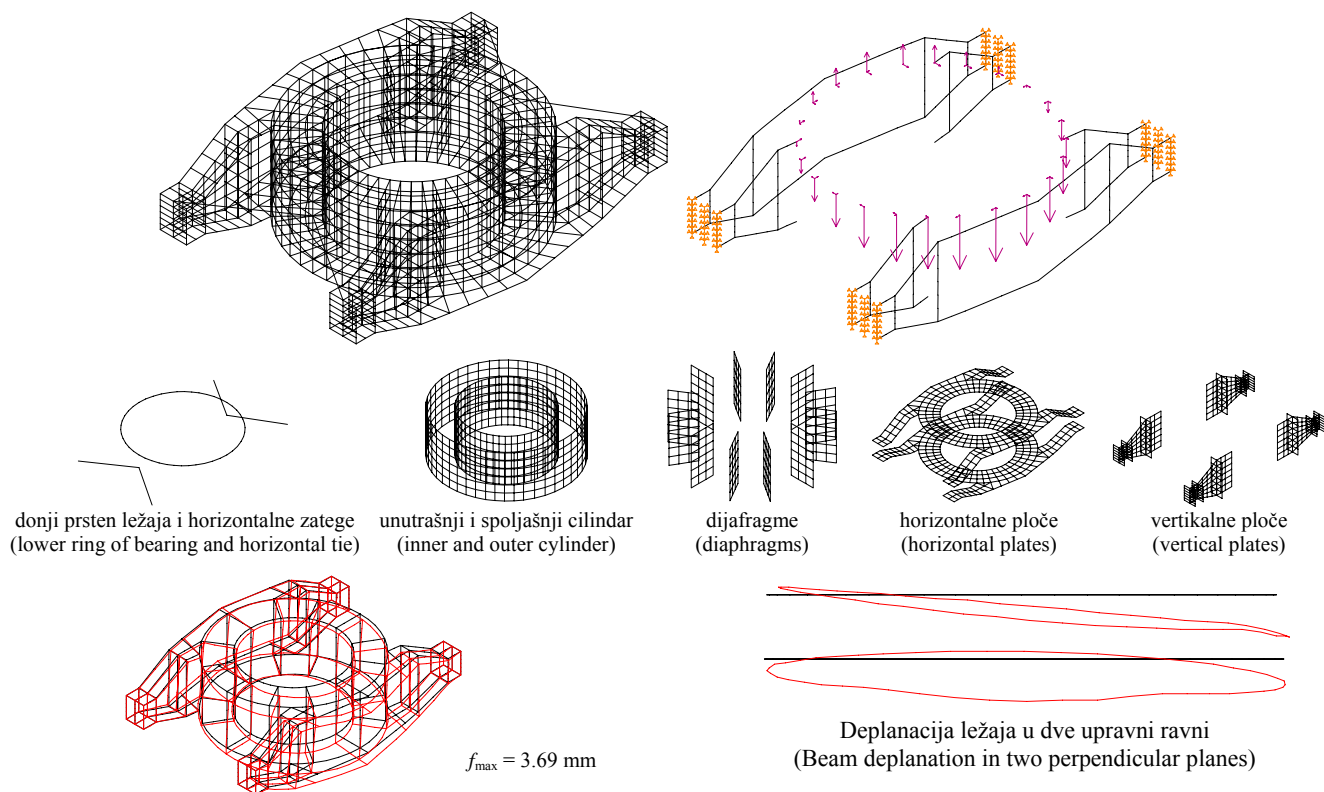
Slika 13. Računski model i deformacija
Figure 13. Computational model and deformation.

The excavator lower assembly suffered several partial and complete cracking of assembly connection beams (see Fig. 12). Model and numerical results are shown in Fig. 13 and 14. Table 2 shows the analysis of the old and new solution.

Inappropriate lower assembly structural behaviour can be repaired by adding vertical plates. Behaviour would also be significantly improved by increasing horizontal plate and cylinder thickness, but this is technically not reasonable.

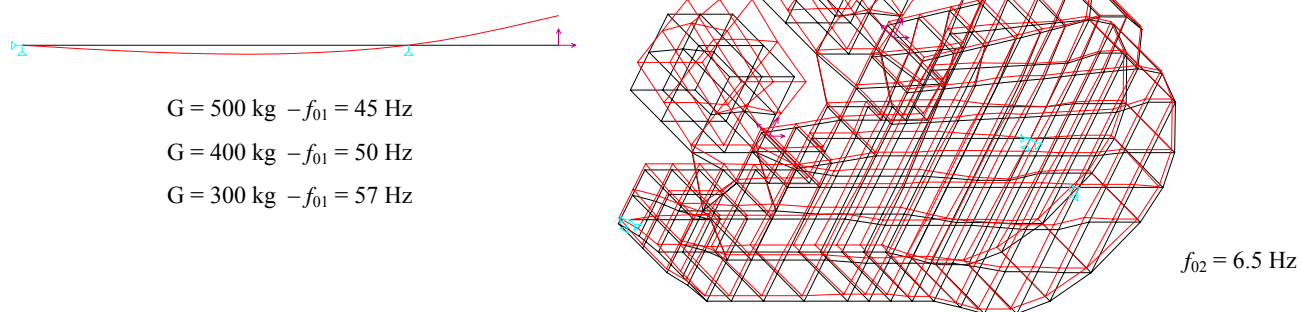
Slika 21. Dinamički model ulaznog vratila i reduktora sa motorima
Figure 21. Dynamic model of the driving shaft and transmission with motors.

The numerical model of the driving shaft and first form oscillations with coupling weight affecting its eigen-frequency value is shown in Fig. 21. The coupling weight has a very negative effect on first eigen-frequency (the coupling must be lighter than 400 kg). A reduced numerical dynami-

cal model of the whole transmission with motors, as well as the second form of oscillations are shown in Fig. 21. This model confirms negative effects of the motor's vertical oscillation that occur at many other frequency values.

Successful transmission operation in the following four months (until replacement for other reasons) was achieved only by increasing the rigidity of transversal motor beams. It was impossible to replace the coupling with a lighter one.

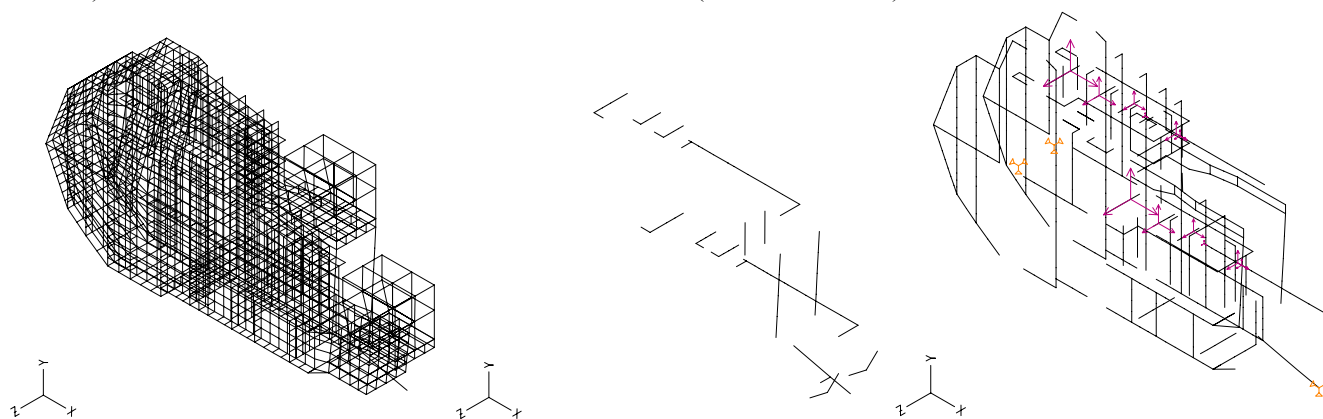
Slika 22. Računski model reduktora
Figure 22. Computational model of the transmission.

The computational transmission model with beams, shafts and power machines is shown in Fig. 22. The first eight eigen-frequencies for variants of coupling placement and weight are given in Table 4. The number of revolutions of the electric motor is 980 min^{-1} , which creates induction at 16.3 Hz frequency, and at multiple subsequent values ($2 \times 16.3 = 32.6 \text{ Hz}$).

Placing the heavier coupling side on the transmission or on the motor must be decided after numerical-experimental diagnosis.

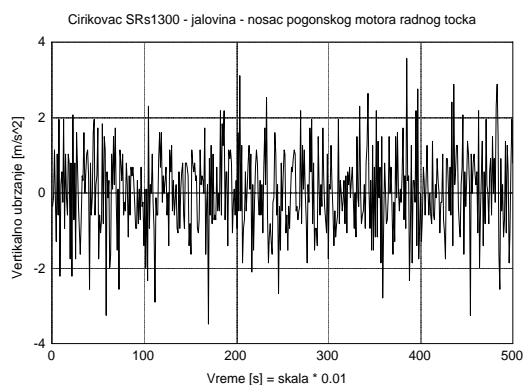
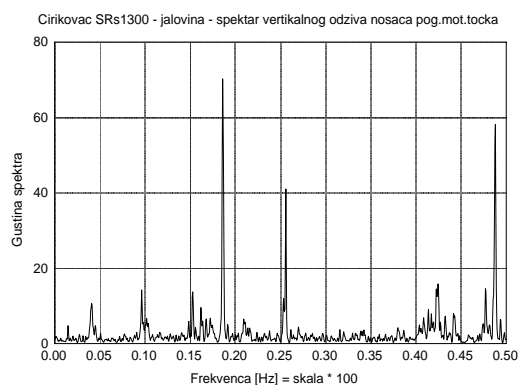
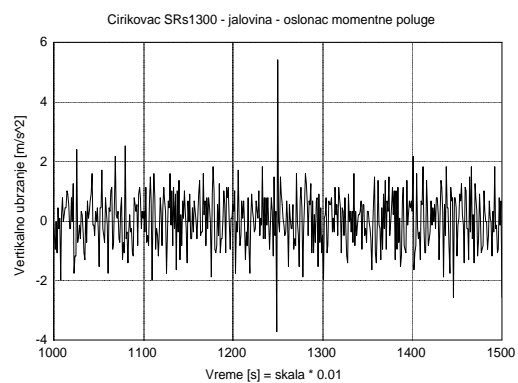
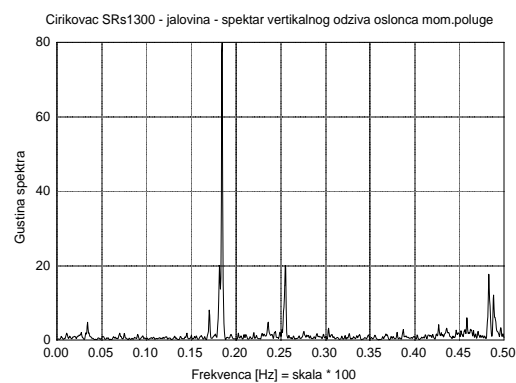
Slika 27. Poprečno ubrzanje u vremenskom (levo) i gustina spektra u frekventnom domenu (desno)
Figure 27. Transversal acceleration in time (left) and spectrum density in frequency domain (right).

Comment on measuring: the accelerations overpasses allowed values ($a_{dmax} = 2 \text{ m/s}^2$); the response of the digging system is a strong signal at frequencies 3, 4, 12, 14, 18, 25, and 49 Hz, and slightly weaker at frequencies 2, 5, 7, 9, 13, 15, and 23 Hz, and these frequencies are tightly correlated to the induced and eigen frequencies of digging transmission, i.e. the transmission may easily approach resonance in operation. This transmission had suffered failure. This type of transmission had failures and still has operating problems also at other basins. This confirms that poor behaviour is identified. Replacement, or global revitalisation of the digging transmission is recommended.

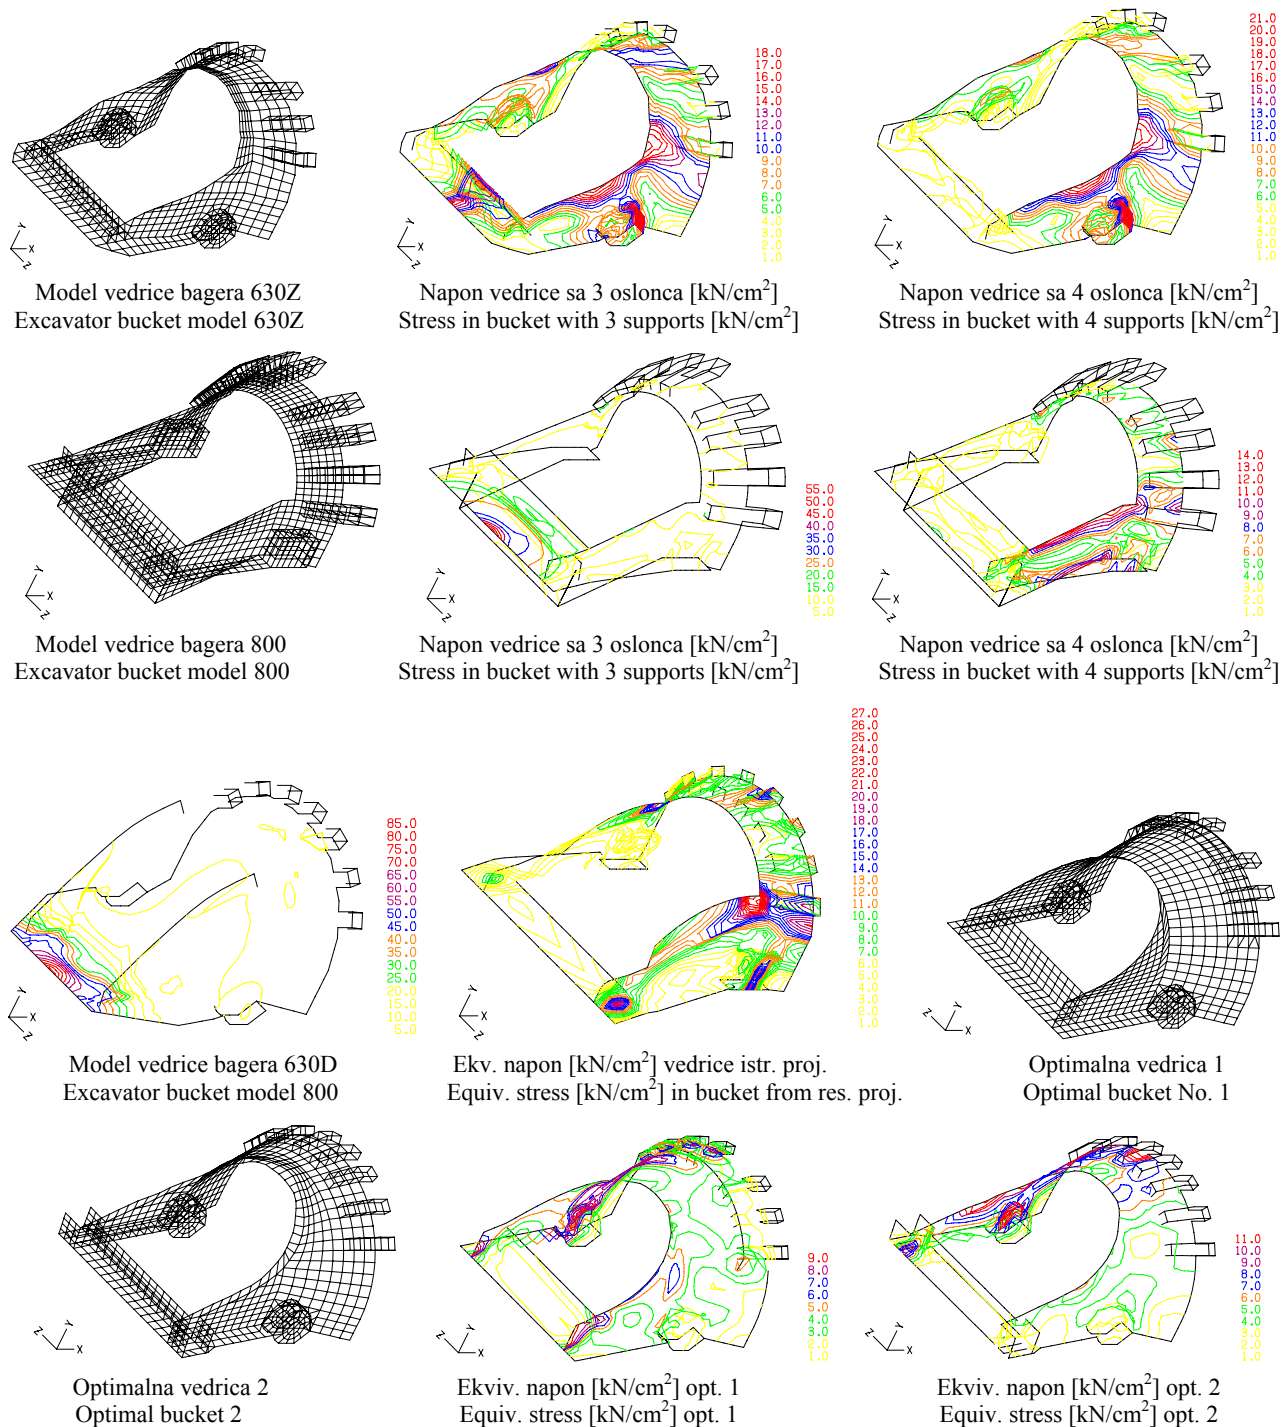
Slika 28. Dijagnostika čvrstoće nekoliko varijanti vedrica
Figure 28. Strength diagnostics for several bucket variants.

Comment on optimal variant No. 1: very low strain and stress levels with small stress concentration; very low weight; strain energy is the lowest; stress distribution is satisfactory.

Comment on optimal variant No. 2: low strain and stress levels with minimal stress concentration; the weight is on the existing level; satisfying strain energy; stress distribution is a little less satisfying.

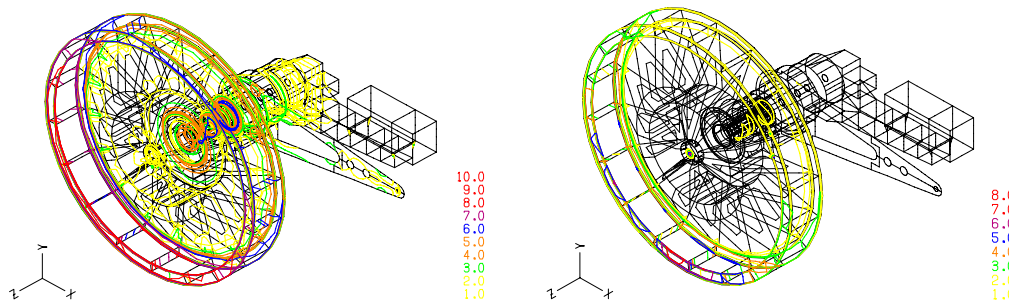
Slika 30. Raspodela napona [kN/cm²] i energije deformisanja [kNcm]
Figure 30. Stress [kN/cm²] and strain energy [kNcm] distribution.

Maximal deformation of the digging system under given load is 5.6 cm, and relates to torsion of the operating wheel. The stress field and strain energy of the digging system are shown in Fig. 30.

- strains in the structure are small, only torsion of the operating wheel is present,
- the stress level is low with small stress concentration,
- the largest stress is located on the operating wheel,
- the stress in revitalised elements (hollow shaft, transmission) is small.

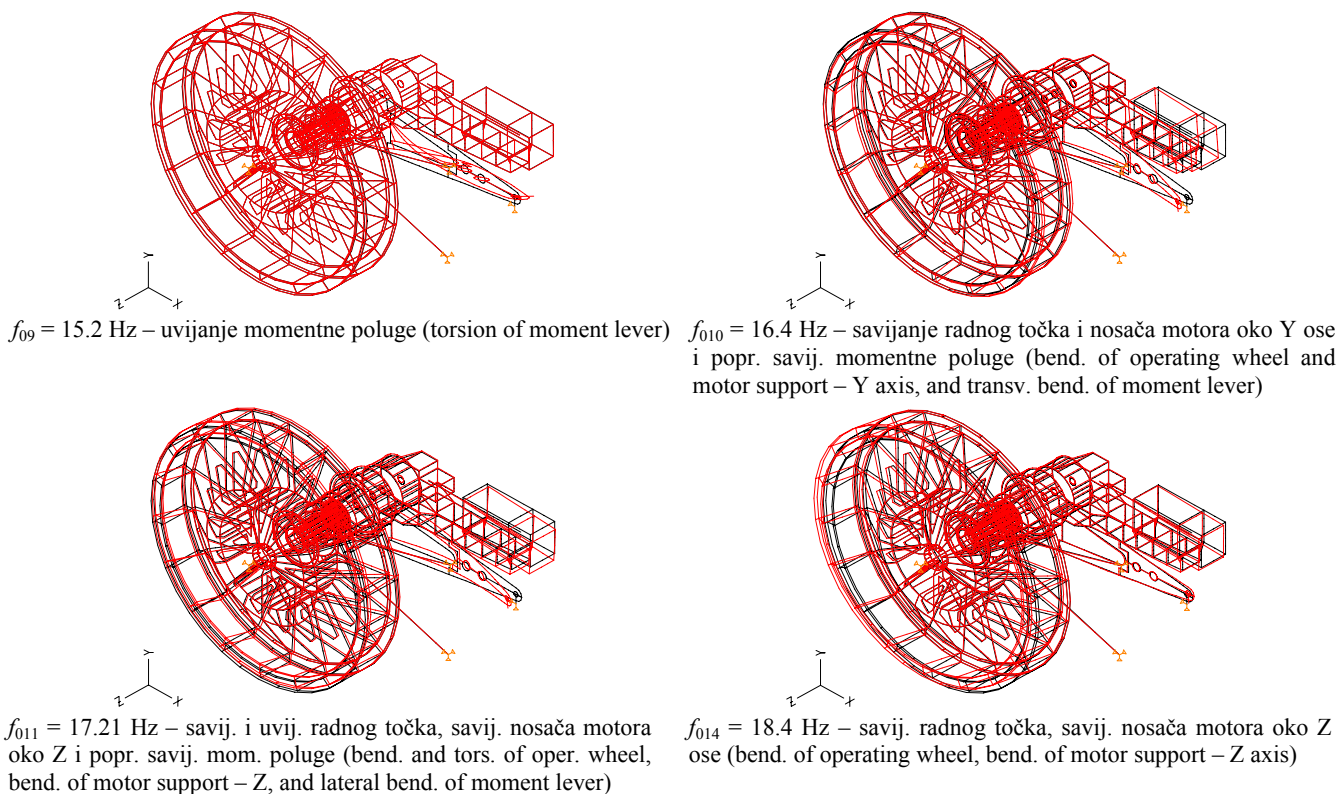
Slika 31. Glavni oblici oscilovanja sistema za kopanje
Figure 31. Main oscillation forms of the digging system.

- no correlations to digging frequencies,
- no fractures of the electric motor and transmission entry shafts,
- in the operating range of the electric motor, insignificant negative oscillating occurs with small amplitudes in the moment lever and motor supports.
