SANACIJE I REKONSTRUKCIJE TRANSPORTERA I ODLAGAČA REPAIR AND RECONSTRUCTION OF BELT WAGONS AND STACKERS

REPAIR AND RECONSTRUCTION OF THE SUPPORT ON THE LOWER ASSEMBLY OF THE ARS1400 O&K STACKER (OPEN-CAST MINE *TAMNAVA ISTOK*)

REPAIR AND RECONSTRUCTION OF ROTATING STACKER PLATFORM ARS 1400 O&K

REPAIR AND REVITALIZATION OF THE SUPPORT ON BELT WAGON BRS/ARS O&K

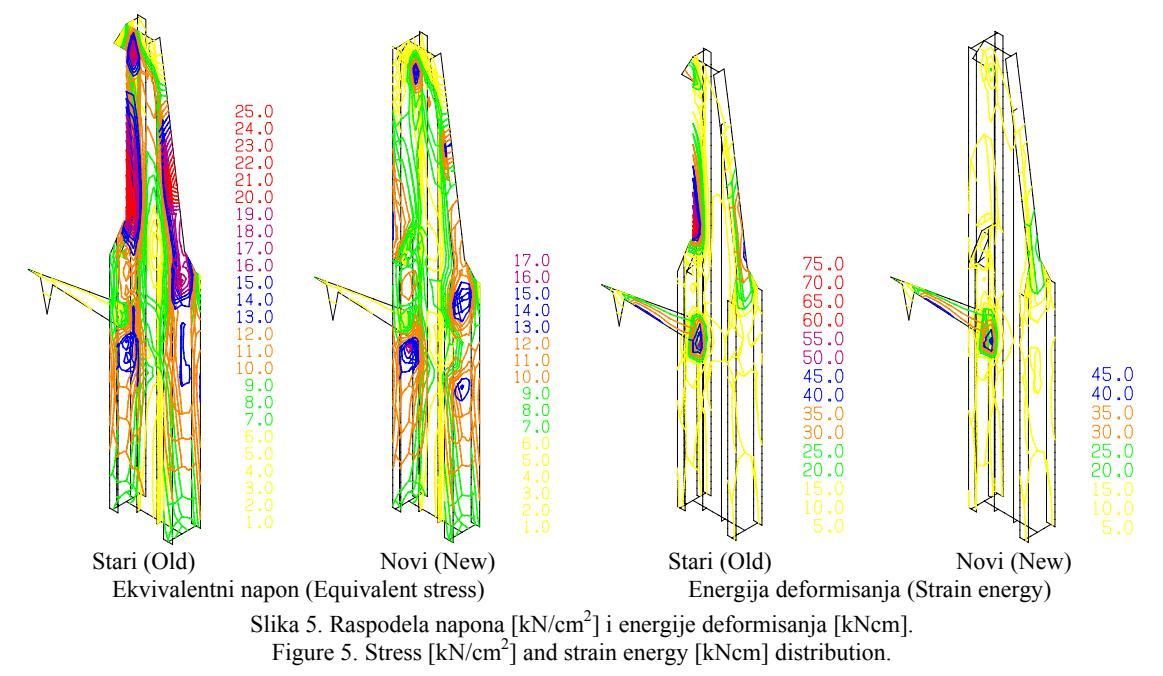
Rekonstrukcija je dovela do uklanjanja uvijanja stuba, značajnog smanjenja savijanja, smanjenja napona za 37,5% i značajnog ublaženja koncentracije napona. The numerical model is shown in Fig. 4. The suggested reconstruction was performed by extending the plate b_2 and its reinforcement a_2 (thickness of both plates is 10 mm) up to the top of the support, and also by partial plate reinforcements d_1 and d_2 with plates $500 \times 1500 \times 20$ mm.

Postojeći – stari model (Existing – old model) Rekonstruisani – novi model (Reconstructed – new model) Slika 4. Računski modeli stuba odlagača (postojeći i rekonstruisani).

Figure 4. Numerical models of the stacker support (existing and reconstructed).

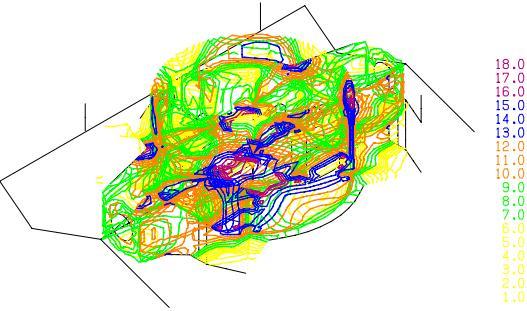
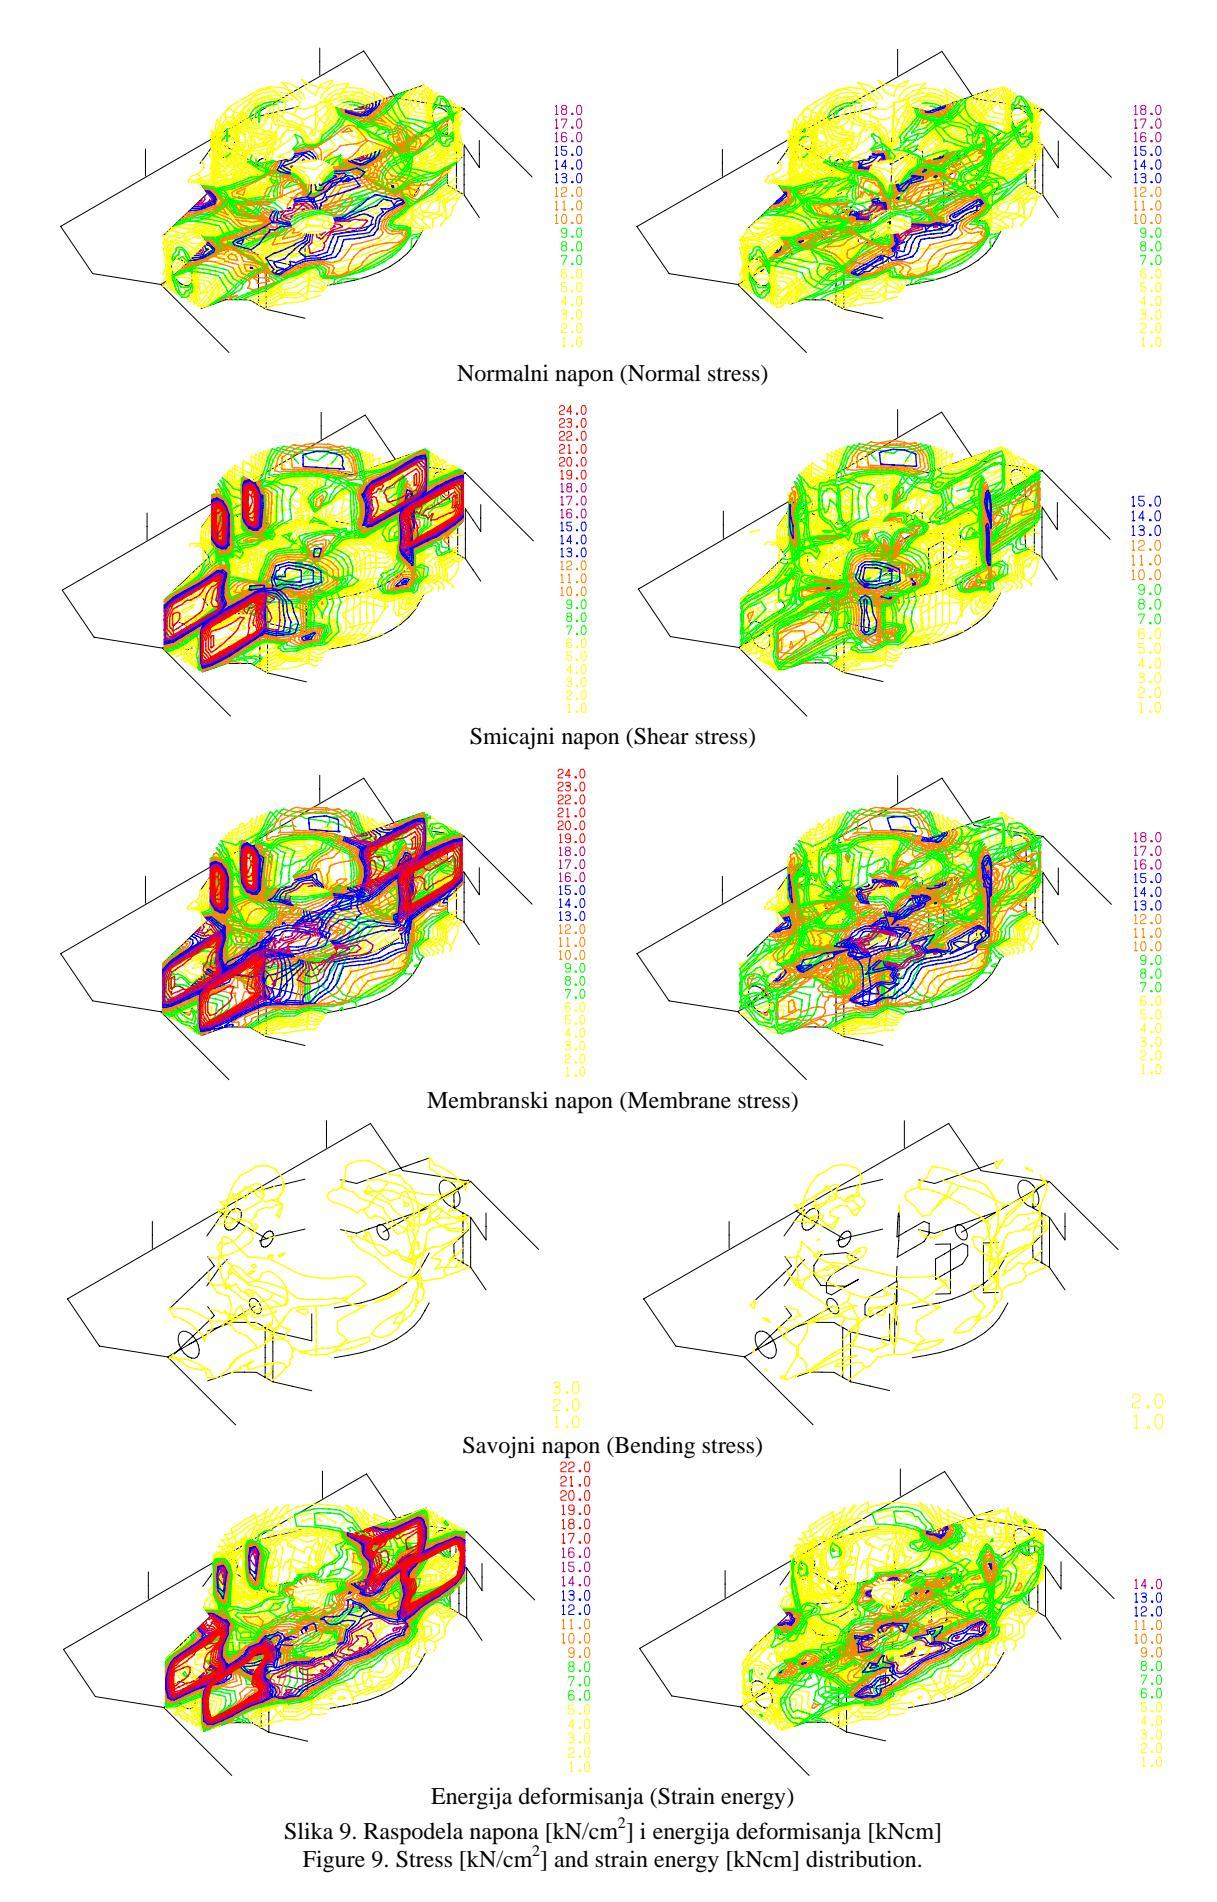
Postojeći model (Existing model) Rekon

Rekonstruisani model (Reconstructed model)

Ekvivalentni napon (Equivalent stress)
