INTEGRITET CEVOVODA HIDROELEKTRANE

INTEGRITY OF PENSTOCK OF HYDROELECTRIC POWERPLANT

Originalni naučni rad / Original scientific paper
UDK /UDC: 621.643.2-112.81 669.15-462-112.81
Rad primljen / Paper received: 10.09.2005.

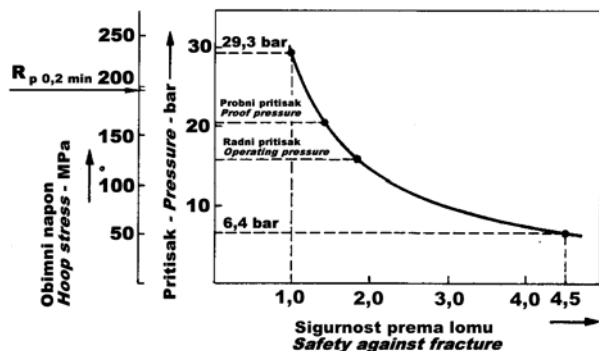
Slika 5. Promena sigurnosti prema lomu sa opterećenjem
Figure 5. Safety against fracture with load.

depended on loading (Fig. 5). This diagram enabled to define program for penstock proof pressure testing, which was performed at an outer temperature between 1 and 4°C. Brittle fracture occurred at the pressure of 15.2 bar, which corresponded to hoop stress of only 120 MPa, well below steel yield stress (190 MPa). The view of penstock after this test is presented in Fig. 6. After these tests the owner decided to leave the intention to use the penstock.

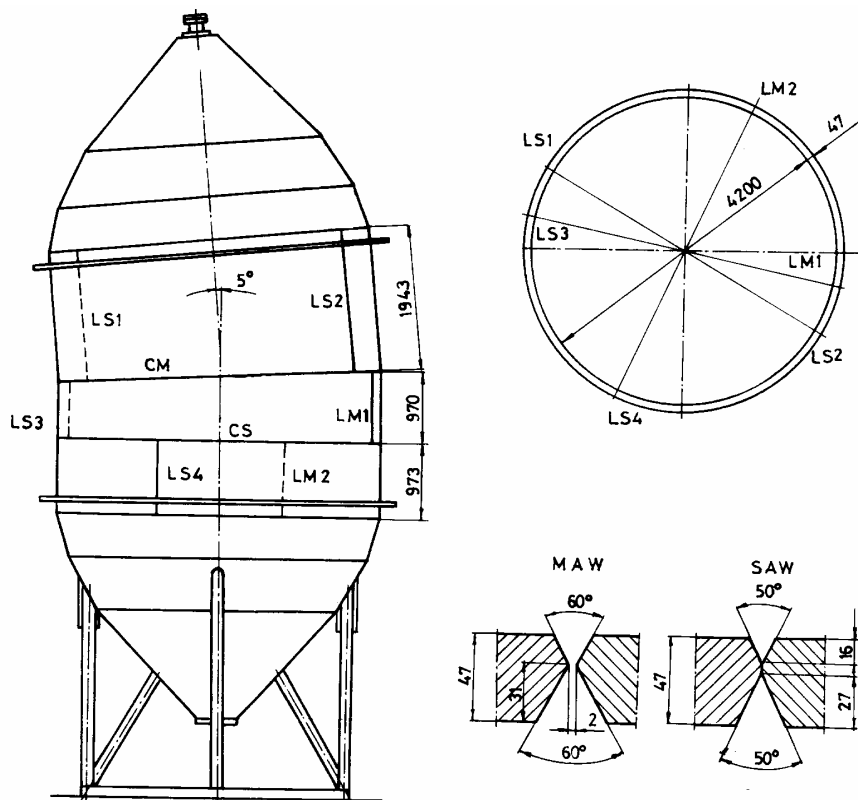
The full-scale model, which presents the most stressed penstock segment, is given in Fig. 9, corresponds to Section 3-3 (Fig. 2). Cylindrical mantle, 420 mm in diameter, designed with 5° knee corresponding to the penstock transition segment, was covered with two shaped lids. Manual arc welding (MAW) and submerged arc welding (SAW) were used.

Slika 9. Konstrukcija i dimenzije dela cevovoda na modelu pune razmere. LS1-LS4 - uzdužni EPP zavareni spojevi, LM1-LM2 - uzdužni E zavareni spojevi, CS - kružni EPP zavareni spoj, CM - kružni E zavareni spoj

Figure 9. Design and dimensions of pipeline segment full-scale models. LS1-LS4 - Longitudinal SAW welds, LM1-LM2 - Longitudinal MAW welds, CS - Circular SAW weld, CM - Circular MAW weld.

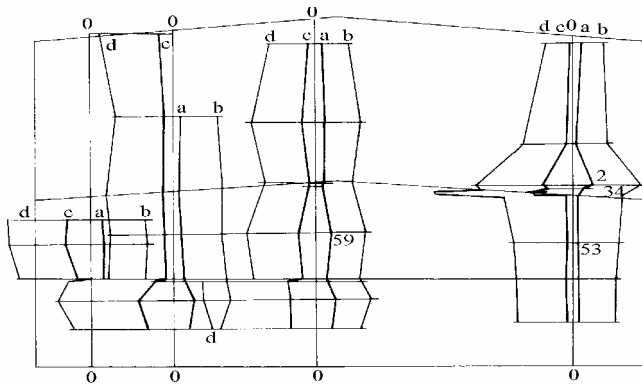
The results of toughness testing were satisfactory, and no clear effect of plastic strain on toughness could be recognized. Good results, obtained in very severe testing condition, as drop weight and explosion bulge test, can serve as a proof of satisfactory crack resistance of weld metals. Again, SAW welded joints exhibited the lowest properties.

Based on these the results it was concluded that initial plastic deformation did not affect significantly penstock safety, because of high toughness of the SM 80P steel and its weldments.

Slika 12. Raspodela deformacija u zavarenim spojevima posle ispitivanja pritiskom

Figure 12. Distribution of strains in weldments after pressurizing.

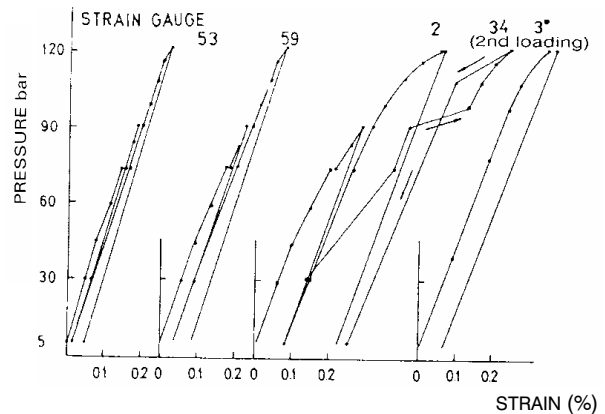
Some typical plots pressure-strain (Fig. 12) should be analyzed. Strain developed uniformly in the base metal (strain gauge 53), circular SAW weld metal, and SAW longitudinal weld metal (strain gauges 2 and 34), as well as on MAW circular weld metal (strain gauge 59). Applied instrumentation allowed quantifying local residual plastic strains that occurred in weld metals after first and second pressurizing stage (Fig. 12). Maximum plastic strain was measured on SAW longitudinal weld metal, in position of strain gauges 2 and 34 for which is an odd form of pressure-strain dependence in the second loading stage is obtained, in the form of a loop in the diagram (Fig. 13). The highest strains in this position are the consequence of acting stress concentration, global, due to 5° knee, and local, due to weldment geometry, and of longitudinal position of the welded joint and its undermatching level. Possible explanation for loop occurrence is the combined effect of undermatching, weld metal strain hardening and strain redistribution during unloading and reloading.

Slika 13. Tipične zavisnosti pritiska i deformacija

Figure 13. Typical relationships between pressure and strain.

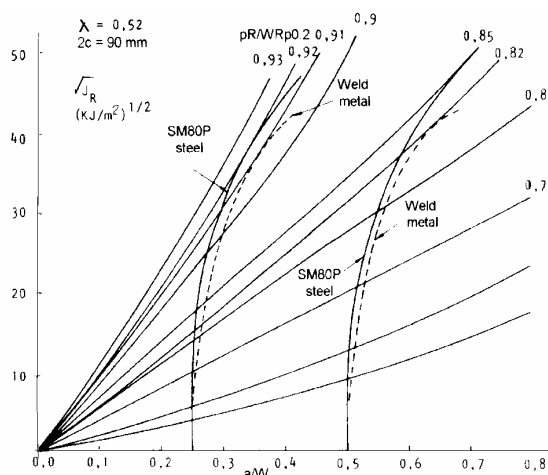
Slika 14. Postupak za predviđanje preostale čvrstoće posude pod pritiskom sa prslinom, sa silom rasvoja prsline i J-R krivama
Figure 14. Procedure for residual strength assessment of cracked pressure vessel, with crack driving force and J-R curves.

Krive otpornosti za osnovni metal - čelik SM80P i EPP metal šava su dobijene na epruvetama za savijanje u tri tačke (SENB) 22,5×45×180 mm prema standardu ASTM E1152. One su prenete u isti dijagram sa silama razvoja prsline na sl. 14. Za pretpostavljeni odnos $a/W = 0,25$ (dubina prsline $a = 11,75$ mm) prsline će rasti stabilno 3,75 mm u metalu šava i 4,25 mm u osnovnom metalu, sa kritičnom vrednosti pritiska za brzi lom 155 bar i 144 bar, respektivno. Za $a/W = 0,5$ ($a=23,5$ mm) te vrednosti su 8,5 mm i 140 bar za osnovni metal, a 6,1 mm i 104 bar za metal šava.
