## INVESTIGATION OF FAILURE ANALYSIS FOR AISI 4340 STEELS ON NEAR THRESHOLD REGION

Originalni naučni rad / Original scientific paper  
Rad primljen / Paper received: 6.03.2024  
<https://doi.org/10.69644/ivk-2025-03-0413>

Adresa autora / Author's address:  
Turkish Aerospace Inc., Ankara, Turkey  
S. Çalışkan <https://orcid.org/0000-0002-9276-8492>  
\*email: [salim.caliskan@tai.com.tr](mailto:salim.caliskan@tai.com.tr)

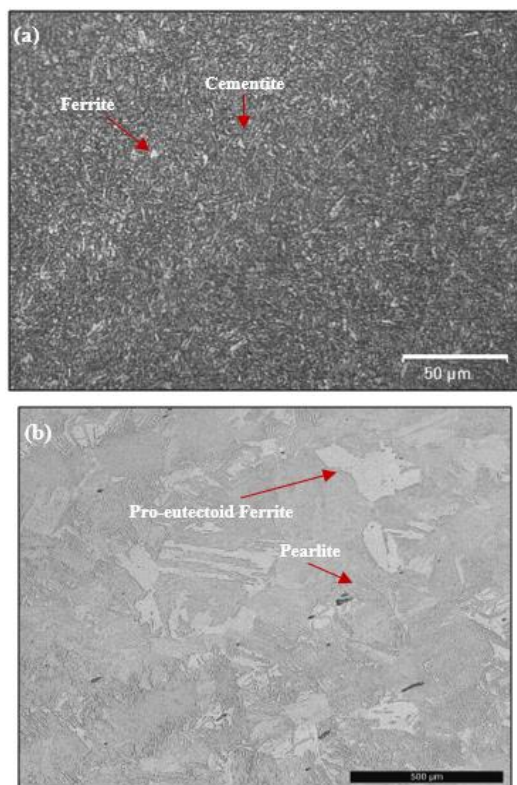
Fig. 1 Optical micrographs of the specimens: tempered (a) and annealed condition (b)

A total of 12 specimens are studied for crack growth tests. After heat treatment, the following mechanical properties are determined for each specimen type. Tempered specimens have an ultimate strength of 1080 MPa and a hardness of 29 HRC, while the annealed specimens have an ultimate strength of 820 MPa and hardness of 17 HRC. In terms of microstructure, tempered microstructure results in tempered martensite with stable ferrite and cementite phases; on the other hand, annealed microstructure shows pro-eutectoid ferrite phase and pearlite phase as seen in Fig. 1.
