# INVESTIGATION OF SURFACE TEXTURING FOR ENHANCING THE ANTI-VIBRATION SUPPORT STRUCTURE OF HEAT EXCHANGER TUBES

Originalni naučni rad / Original scientific paper  
Rad primljen / Paper received: 23.02.2026  
<https://doi.org/10.69644/ivk-2026-siA-0075>

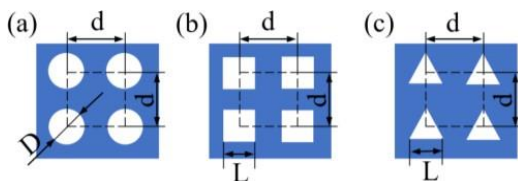
Figure 1. Schematic diagram for calculating micro-texture surface density: a) circular dimple micro-texture; b) square pit micro-texture; c) equilateral triangular pit micro-texture.

The tribological effects of a texture are closely related to its geometric parameters, including morphology, size, arrangement, and area density, /24/. Generally, increasing the texture density can reduce the real contact area, which helps to lower the friction coefficient. Furthermore, the influence mechanisms of texture depth and size differ under dry friction and lubricated conditions. For this reason, three geometric shapes are designed to characterise the surface texture regions as shown in Fig. 1.

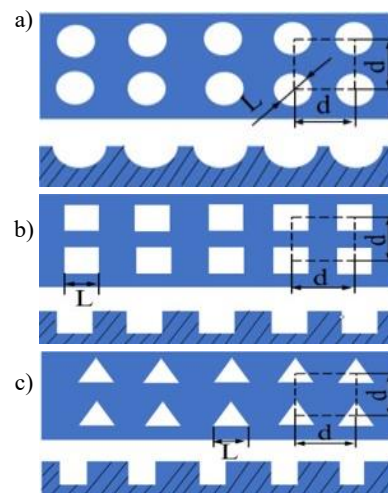
Figure 2. a) Circular dimple; b) square pit; c) triangular pit.

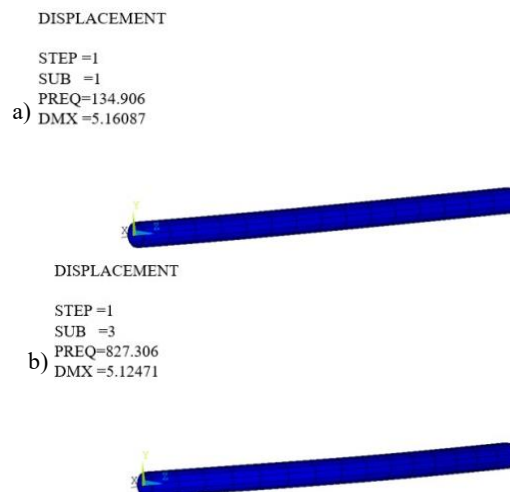
Figure 3. Simulation results of natural frequencies for a structure with one end fixed and the other end free: a) first-order natural frequency; b) second-order natural frequency.

By using the solid 188 beam element in ANSYS®, a finite element model of 690 alloy heat exchange tube is established. One end fixed support constraint is applied, one end is free, and one end is fixed support and one end simple support constraint on both ends of the heat exchange tube for modal analysis. At the same time, the subspace method is used to extract the first 5 natural frequencies of the heat exchange tube. Figures 3 and 4 show the simulation results of the first 2 natural frequencies of the heat exchange tube under two different constraint conditions.

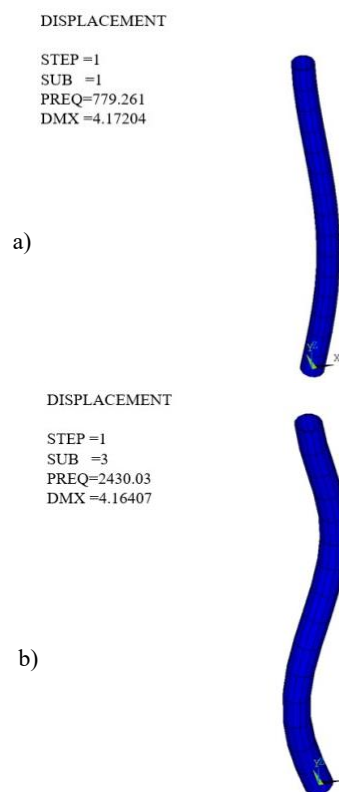
Figure 4. Simulation results of natural frequencies for a structure with one end fixed and the other end simply supported: a) first-order natural frequency; b) second-order natural frequency.

The empirical first-order natural frequency of the specific testing configuration (fixed at the top, supported by the dual AVBs at the bottom) is measured at 356.59 Hz. This value lies perfectly between the extremes of the completely free

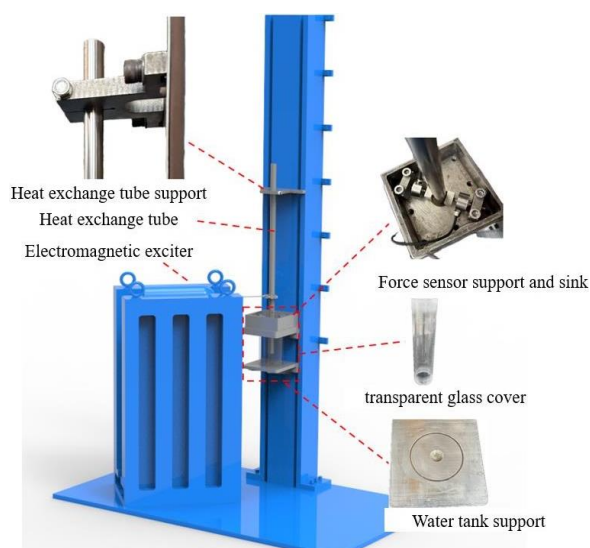
Figure 5. Physical picture of wear test device.

The core impact-sliding fretting wear experiments are executed on a custom-engineered, multi-environment vibration testing platform. As illustrated in the apparatus schematic (Fig. 5), the vertical architecture of rig centres around a heavy-duty structural column. The Inconel 690 heat exchanger tube is mounted vertically parallel to this column, with its upper terminus rigidly fixed by a dedicated tube support bracket to eliminate parasitic frame compliance. An ES-1-150 electromagnetic vibration exciter, positioned adjacently, delivers highly precise, computer-controlled sinusoidal dynamic loads. This exciter is coupled to the tube via a 5 mm diameter 304 stainless steel excitation rod. At the lower testing interface, the apparatus features a specialised force sensor support and water tank assembly. Within this assembly, the paired AVB specimens are mounted. The excitation force is applied at an angle of  $45^\circ$  relative to the AVB mounting bracket, causing the tube to undergo a complex, bi-directional orbital motion that forces it to impact and slide against the AVBs located 50 mm from the lower free end of the tube. To simulate the submerged aqueous environment, a transparent glass containment cover is installed over the contact zone, securely resting on the bottom water tank support base, which allows for full fluid immersion of the friction pair while enabling visual monitoring.

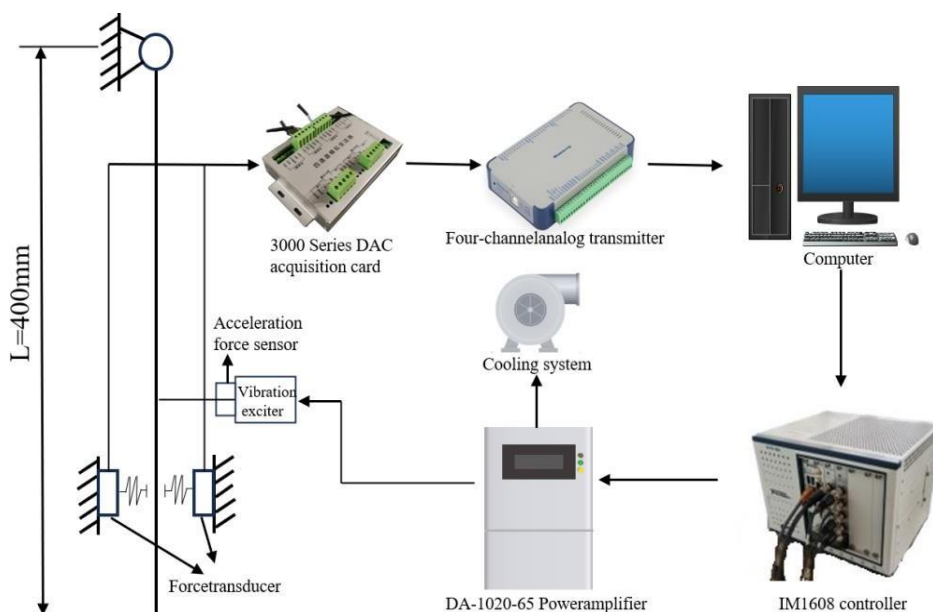
Figure 6. Flowchart of the wear test principle.

The dynamic loading protocol applied a constant 70 Hz sinusoidal excitation signal. As detailed in the system schematic, the experimental operation is governed by an integrated closed-loop control and data acquisition architecture. The desired excitation parameters are programmed via the master computer and transmitted to IM1608 controller. This control signal is subsequently boosted by a DA-1020-65 power amplifier - maintained by a dedicated cooling system to ensure thermal stability during extended operation - to actuate the vibration exciter coupled to the 400 mm heat exchanger tube (Fig. 6). To evaluate the effect of varying kinetic energy inputs, the excitation load ( $F$ ) is incrementally tested at 40 N, 50 N, 60 N, and 70 N. Each individual

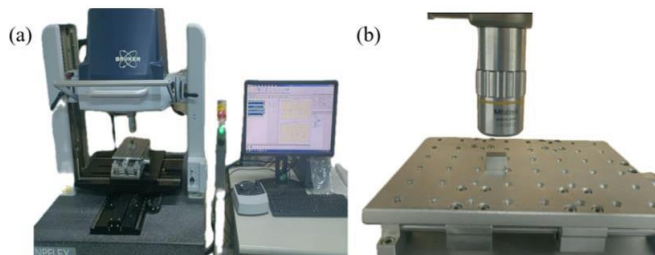
Figure 7. Nano-surface Interferometer: a) appearance of the equipment; b) observation platform.

The application of femtosecond laser surface texturing fundamentally alters both the micro-geometry and localised mechanical properties of the 405 stainless steel AVB substrate. To precisely quantify these topographical transformations, a Bruker NPFLEX 3D optical nano-surface interferometer is employed for high-resolution baseline and post-ablation metrology. As illustrated in the metrology setup, the system comprises the main interferometry unit coupled with a dedicated data analysis workstation (Fig. 7a). During the measurement process, the precisely machined 405 stainless steel AVB block is firmly secured on a highly stable, perforated sample stage.

This configuration allows the high-magnification objective lens, positioned directly above the sample, to perform non-contact optical profiling of the micro-scale surface topography (Fig. 7b). Utilising this advanced equipment, the

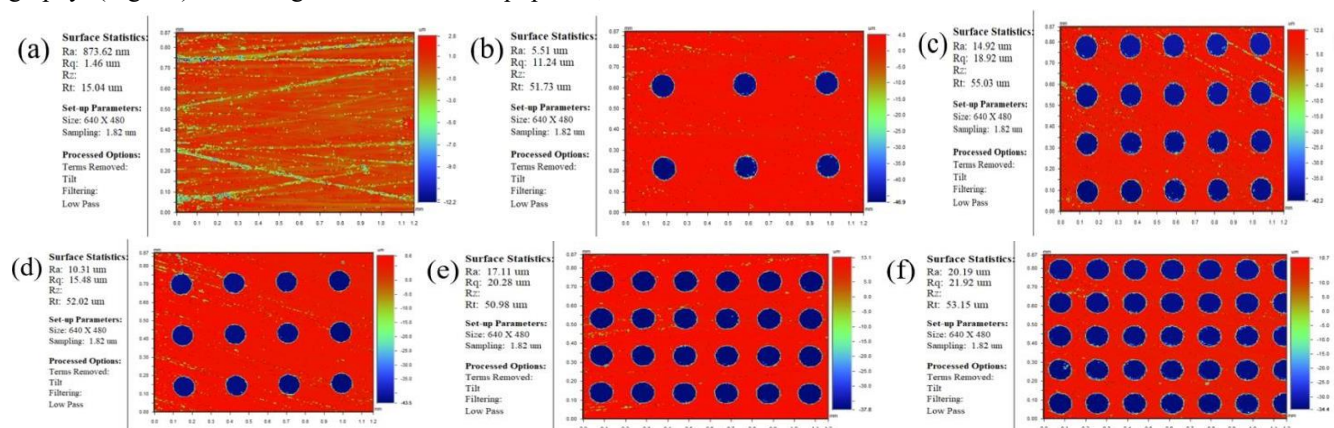
Figure 8. Roughness of the second batch of anti-vibration strips: a) smooth surface; b) circular pits with 5 % texturing rate; c) circular pits with 10 % texturing rate; d) circular pits with 14.8 % texturing rate; e) circular pits with 19.6 % texturing rate; f) circular pits with 24.2 % texturing rate.

To provide an intuitive visualisation of this topographical evolution, the two-dimensional pseudo-colour contour maps and their associated statistical roughness parameters are analysed in detail. Figure 8a illustrates the baseline smooth surface, exhibiting a uniform profile characterised by minor polishing marks and a minimal average roughness  $R_a = 873.62 \text{ nm}$ . Figures 8(b-f) depict the array of circular micro-dimples engineered at varying surface area densities. In these optical profiles, the deep blue circular zones correspond to the laser-ablated cavities, which contrast sharply with the red and orange regions representing the pristine, load-bearing plateaus. Topographical maps clearly display configurations with 5 % (Fig. 8b), 10 % (Fig. 8d), 14.8 % (Fig. 8c), 19.6 % (Fig. 8e), and 24.2 % (Fig. 8f) texture densities. A direct correlation is visually and statistically evident: as structural density of the dimple array increases, there is a systematic escalation in all primary roughness metrics, including  $R_a$ , root-mean-square roughness  $R_q$ , and maximal peak-to-valley height  $R_t$ . This optical characterisation unequivocally confirms that the macroscopic surface asperity profile is a direct geometric consequence of the femtosecond laser's volumetric ablation density.

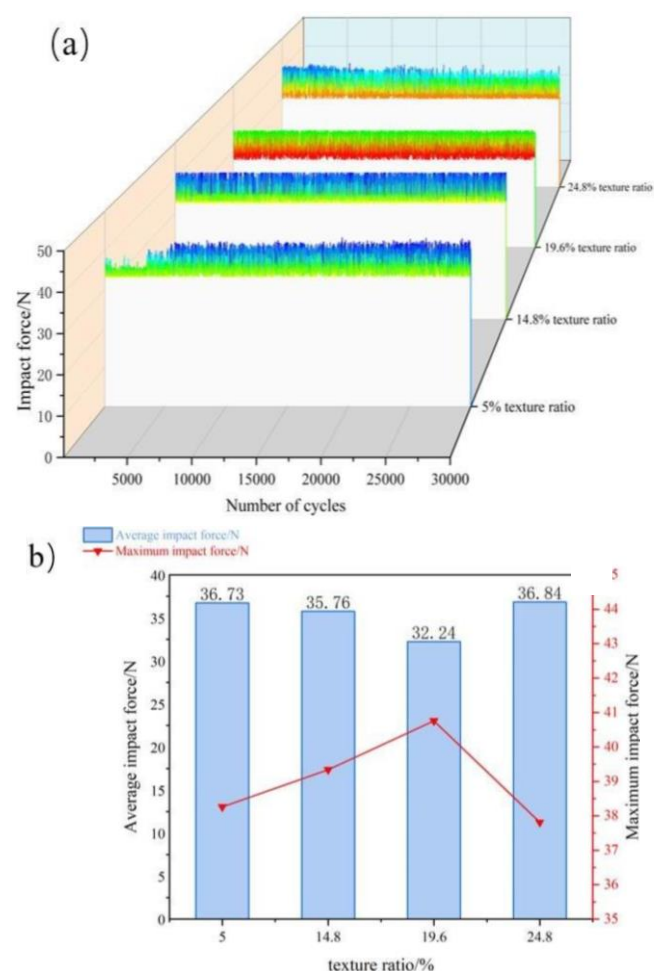
Figure 9. Impact force characteristics under different texture ratios: (a) cyclic impact force curves; (b) average and max. impact force

is systematically evaluated. As illustrated in the cyclic impact force curves (Fig. 9a) and the average and maximal impact force (Fig. 8b), introducing circular micro-dimples at varying surface area densities (5 %, 14.8 %, 19.6 %, and 24.2 %) significantly alters the contact mechanics under the maximal 70 N excitation load in water. The data reveals that the micro-textured surfaces possess a pronounced capability to regulate impact intensity. The average impact force drops to a minimum of 32.24 N at 19.6 % texture density. However, the maximal transient impact force exhibits a counter-trend, peaking near 40.76 N at the 19.6 % density before dropping to its absolute minimum of approximately 37.81 N at the maximal tested density of 24.2 %. This divergence indicates that while intermediate texture densities are effective at reducing steady-state sliding resistance, the highest texture density (24.2 %) provides the optimal structural damping and fluid-cushioning effect required to successfully suppress the most severe, instantaneous impact peaks during high-frequency collisions.

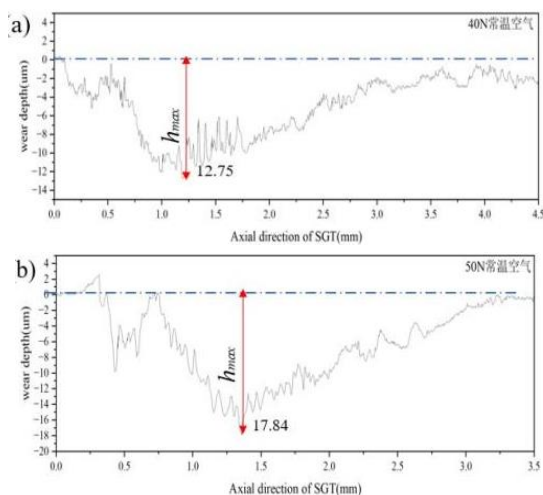
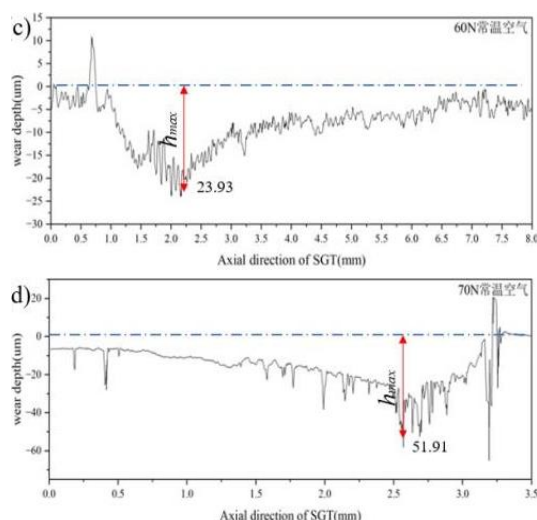
Figure 10. Quantitative analysis of thermal pipe wear under quasi-static vibration loads in ambient air: a)-d) 40-70 N.

Profilometric extraction of wear depth curves along the axial centreline reveals a stark contrast between the two environments. As illustrated in the air environment wear profiles (Fig. 10), the maximal wear depth  $h_{max}$  escalates drastically and nonlinearly with the applied excitation load. At a baseline load of 40 N, the maximal depth is 12.75  $\mu\text{m}$ . As the load increases to 50 N, 60 N, and 70 N, the wear depth surges to 17.84  $\mu\text{m}$ , 23.93  $\mu\text{m}$ , and a staggering 51.91  $\mu\text{m}$ , in respect. This rapid deepening indicates severe stress concentration at contact boundaries under dry sliding conditions, leading to accelerated wall thinning.

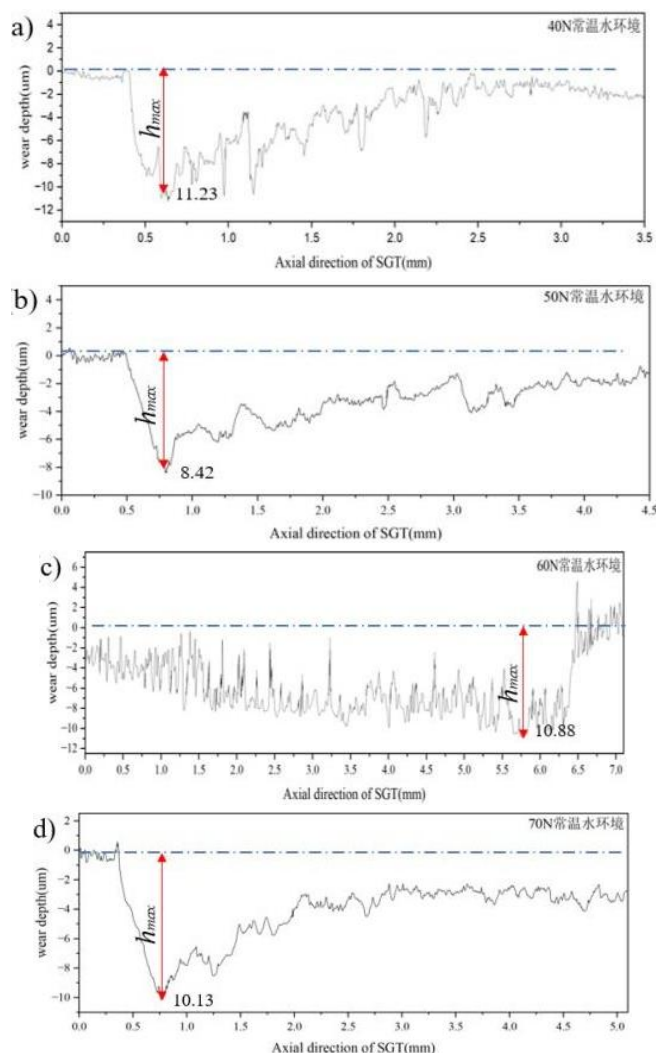
Figure 11. Quantitative analysis of heat exchanger tubing erosion under variable vibration loads in ambient water: a)-d) 40-70 N.

Conversely, the wear depth profiles obtained in the submerged water environment, Fig. 11, demonstrate a profound protective effect. Despite the increasing excitation loads from 40 to 70 N, the maximal wear depth remains remarkably

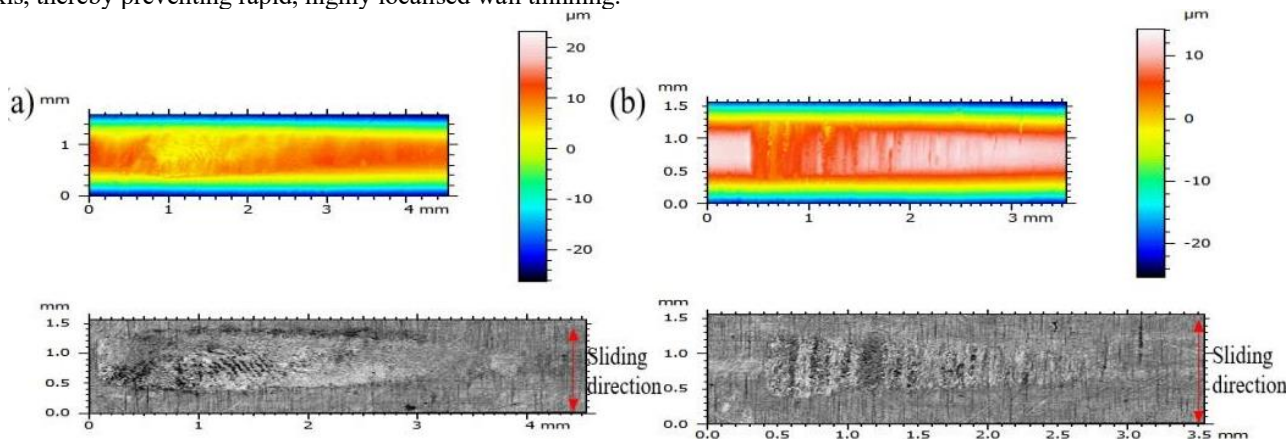
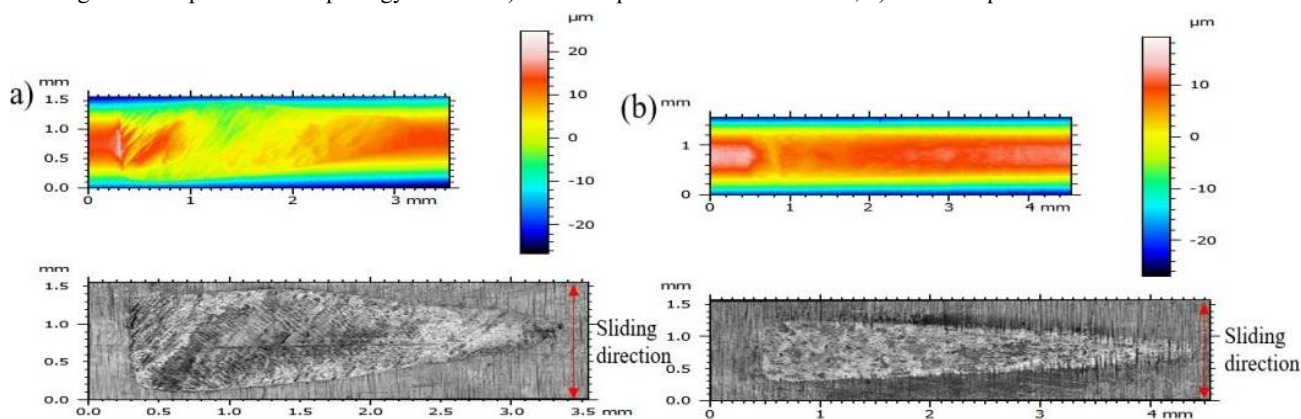
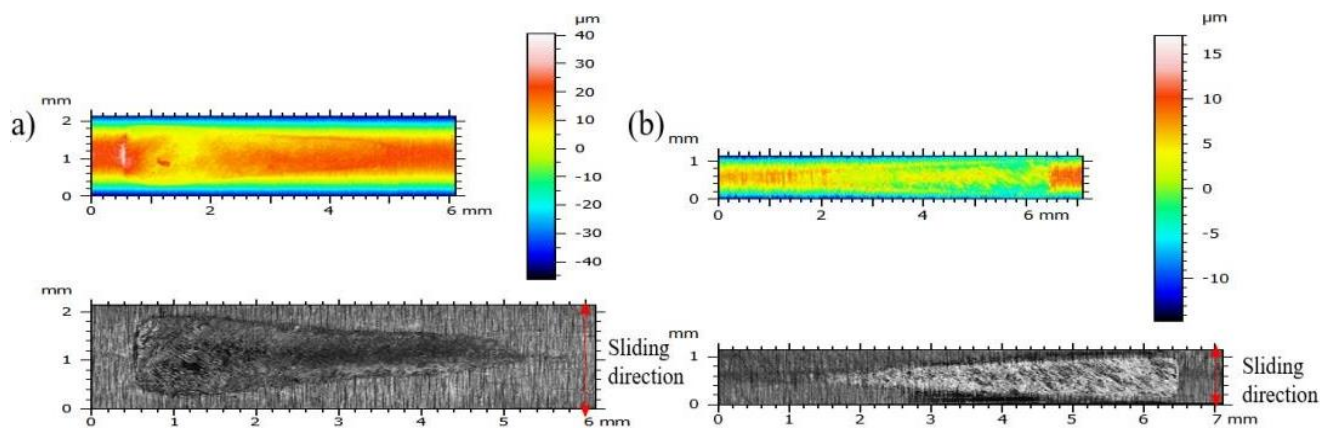
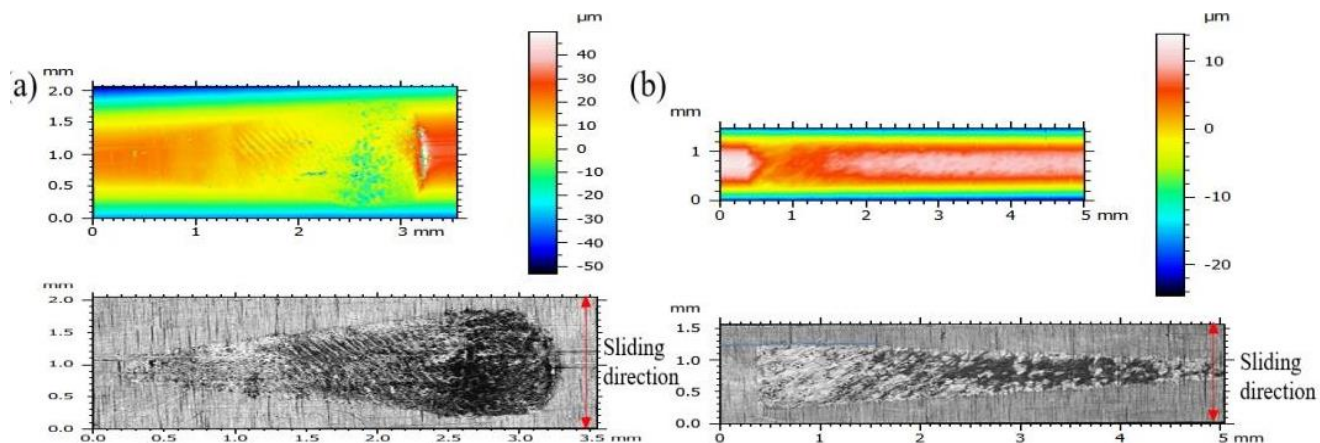
Figure 12. Impact wear morphology of 40 N: a) room-temperature air environment; b) room-temperature water environment.

Figure 13. Impact wear morphology of 40 N: a) room-temperature air environment; b) room-temperature water environment.

Figure 14. Impact wear morphology of 40 N: a) room-temperature air environment; b) room-temperature water environment.

Figure 15. Impact wear morphology of 40 N: a) room-temperature air environment; b) room-temperature water environment.

To provide a more intuitive visualisation of this phenomenon, three-dimensional surface profilometry and two-dimensional optical micrographs are systematically compared across the 40 to 70 N load spectrum (as illustrated in Figs. 12-15). These topographies vividly capture the dimensional evolution of the wear scars. In the ambient air environment, the sliding distance (the width of the scar in the direction of tangential slip) expands significantly as the applied load increases, measuring 1.1 mm at 40 N, 1.3 mm at 50 N, and peaking at 1.7 mm for both 60 N and 70 N. Conversely, the fully submerged water environment effectively suppresses this lateral expansion. The sliding distances in water remain remarkably stable and constrained across the entire load spectrum, measuring only 0.9 mm, 1.0 mm, 0.9 mm, and 1.05 mm, respectively.

Interestingly, while the aqueous medium restricts radial wear depth and tangential slip distance, it promotes axial distribution of the wear area. Morphological analysis reveals that at higher loads (50, 60, and 70 N), the macroscopic lengths of wear scars in water (4.1, 5.4, and 4.6 mm, in respect) consistently exceed those generated in air (3.1, 4.6, and 3.1 mm, respectively). This morphological evidence confirms that the fluid medium provides critical hydrodynamic boundary lubrication. Instead of allowing the impact energy to gouge deeply into a concentrated local point, the lubrication relieves severe localised stress concentrations and redistributes the frictional energy longitudinally along the tube's axis, thereby preventing rapid, highly localised wall thinning.

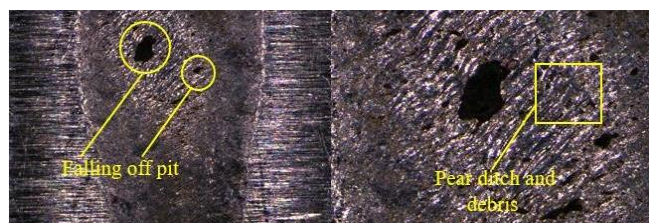
Figure 16. Abrasion marks morphology in a room-temperature air environment.

Ultra-depth microscopic observations further elucidate the fundamental shift in tribological failure mechanisms. In the dry ambient air environment (Fig. 16), the worn surfaces exhibit severe degradation characterised by deep ploughing grooves laden with extruded metal remnants and massive spalling craters (delamination pits). These morphological features are indicative of intense two-body abrasive wear and high-cycle fatigue-induced delamination. The repeated dry impact-sliding induces severe plastic deformation and surface hardening, eventually causing the embrittled material to fracture and detach.

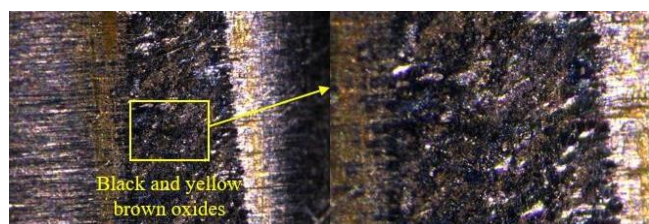
Figure 17. Abrasion marks morphology in a room-temperature water environment.

When the system is submerged in water (Fig. 17), the microscopic morphology changes dramatically. The massive spalling craters disappear, and the deep abrasive ploughing effect is visibly reduced, confirming that the aqueous lubrication effectively mitigates catastrophic fatigue delamination. However, the submerged wear scars are heavily blanketed by a compacted, irregular tribo-layer consisting of black and yellowish-brown oxidative debris.

This indicates that while the water environment reduces gross material removal, it traps the generated wear particulates within the contact patch. The continuous mechanical disruption by these trapped third-body particles, combined with the aqueous environment, facilitates a continuous cycle of mild abrasive ploughing and aggressive oxidative wear. Consequently, to further extend the structural lifespan of heat exchanger tubes and manage this trapped abrasive debris, the application of targeted micro-surface texturing on the anti-vibration bars is proposed as a necessary engineering intervention.

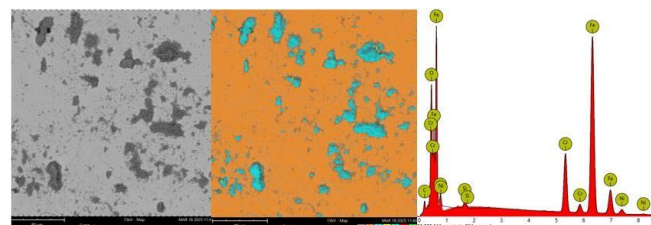
Figure 18. SEM analysis of worn anti-vibration bars-smooth anti-vibration bars in ambient air environment.

As observed under the ambient air environment, Fig. 18, the worn surface of the smooth AVB exposes a massive amount of iron and exhibits numerous wear debris spalling craters. Crucially, these craters are highly enriched with

oxygen, its content can reach 22.01 wt.%, indicating that the substrate experiences pronounced oxidative wear during the dry friction process.

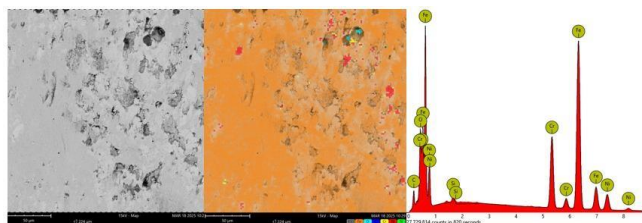
Figure 19. SEM analysis of worn anti-vibration bars-smooth anti-vibration bars in room-temperature water environment.

When submerged in room-temperature water (Fig. 19), the surface of the smooth AVB similarly develops extensive spalling craters. However, EDS analysis reveals that these pits contain a slight amount of oxygen alongside a significant accumulation of nickel. Given that the 405 stainless steel AVB substrate lacks intrinsic nickel, this confirms that material transfer occurs from the Inconel 690 heat exchanger tube to the support structure during the aqueous wear process. This transferred tube material transforms into wear debris and becomes compacted within the substrate's spalling craters, which are primarily generated by continuous fatigue wear. By comparing the oxygen mass fractions, the smooth AVB in air contains 8.01 % more oxygen than in water, demonstrating that oxidative wear is considerably more severe in the dry ambient environment.

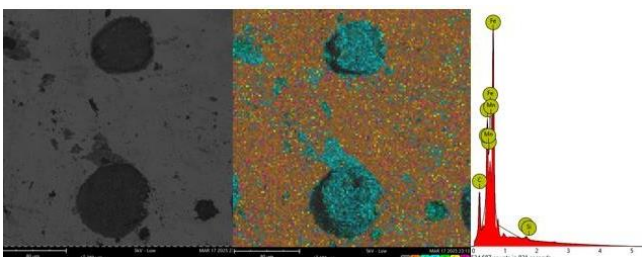
Figure 20. SEM analysis of worn anti-vibration bars-microtextured anti-vibration bars in room-temperature water environment.

Conversely, on the micro-textured AVB operating in room-temperature water environment (Fig. 20), EDS mapping reveals a massive enrichment of oxygen heavily localised within the laser-ablated circular dimples. This concentrated oxidation may be attributed to the high energy density of the laser beam during fabrication, which rapidly elevates the metal surface temperature and accelerates localised oxidation reactions. Nevertheless, oxygen is also detected across the abraded plateau regions outside the dimples, confirming that oxidative wear continues to accompany the impact-sliding interaction in water. Despite this ongoing oxidative wear, the micro-dimples effectively capture and sequester the oxidised debris, thereby preventing severe abrasive degradation.
